# East Morris Street Cottages

312- 318 East Morris Street, Anderson, South Carolina  
Graduate Program in Historic Preservation  
Clemson University/The College of Charleston  
Preservation Studio - Spring 2021

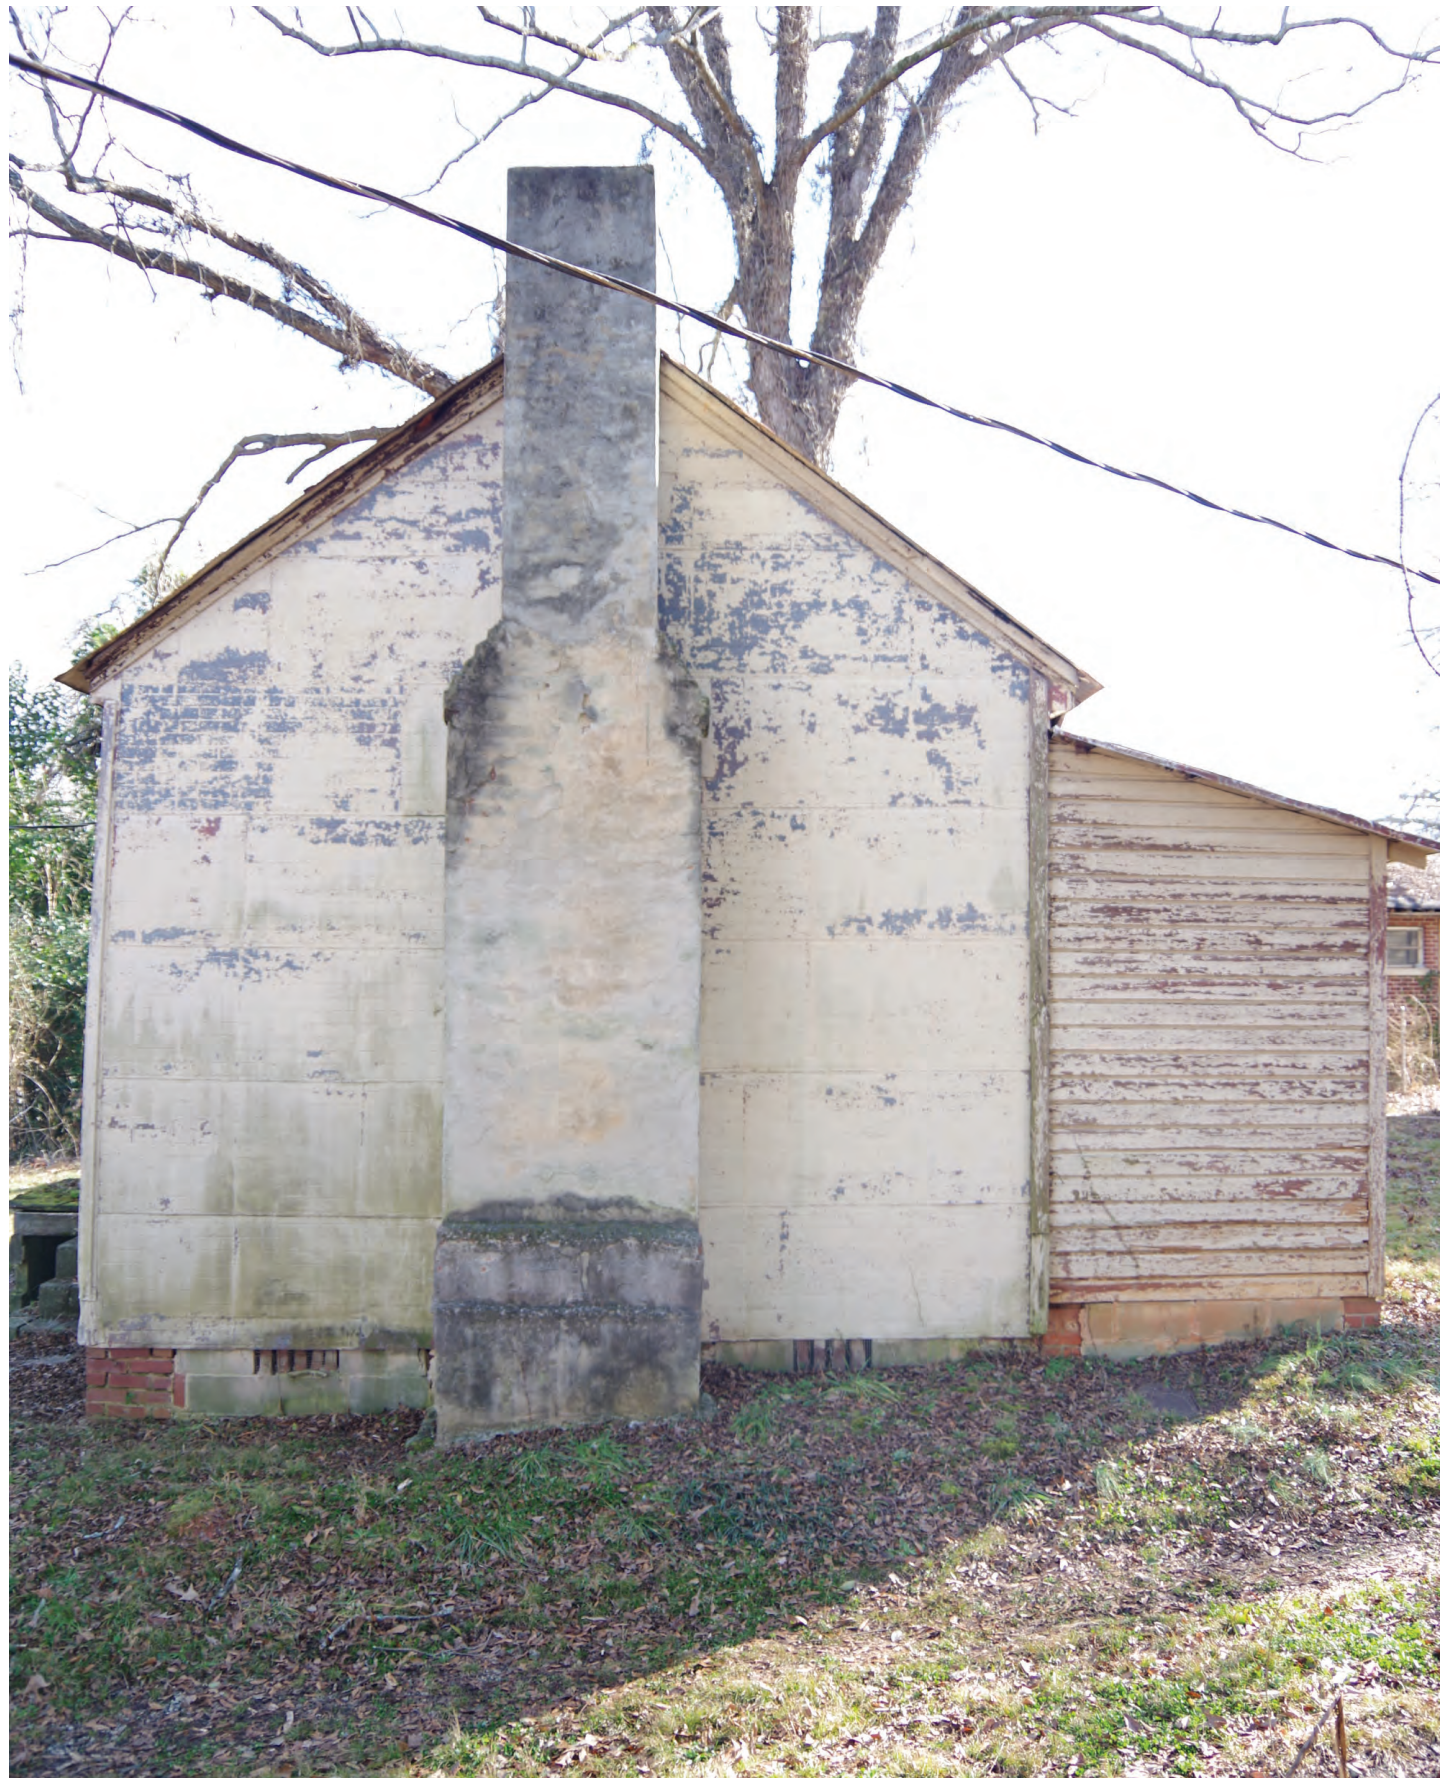
East elevation with addition on north end, brick pier foundation with CMU infill

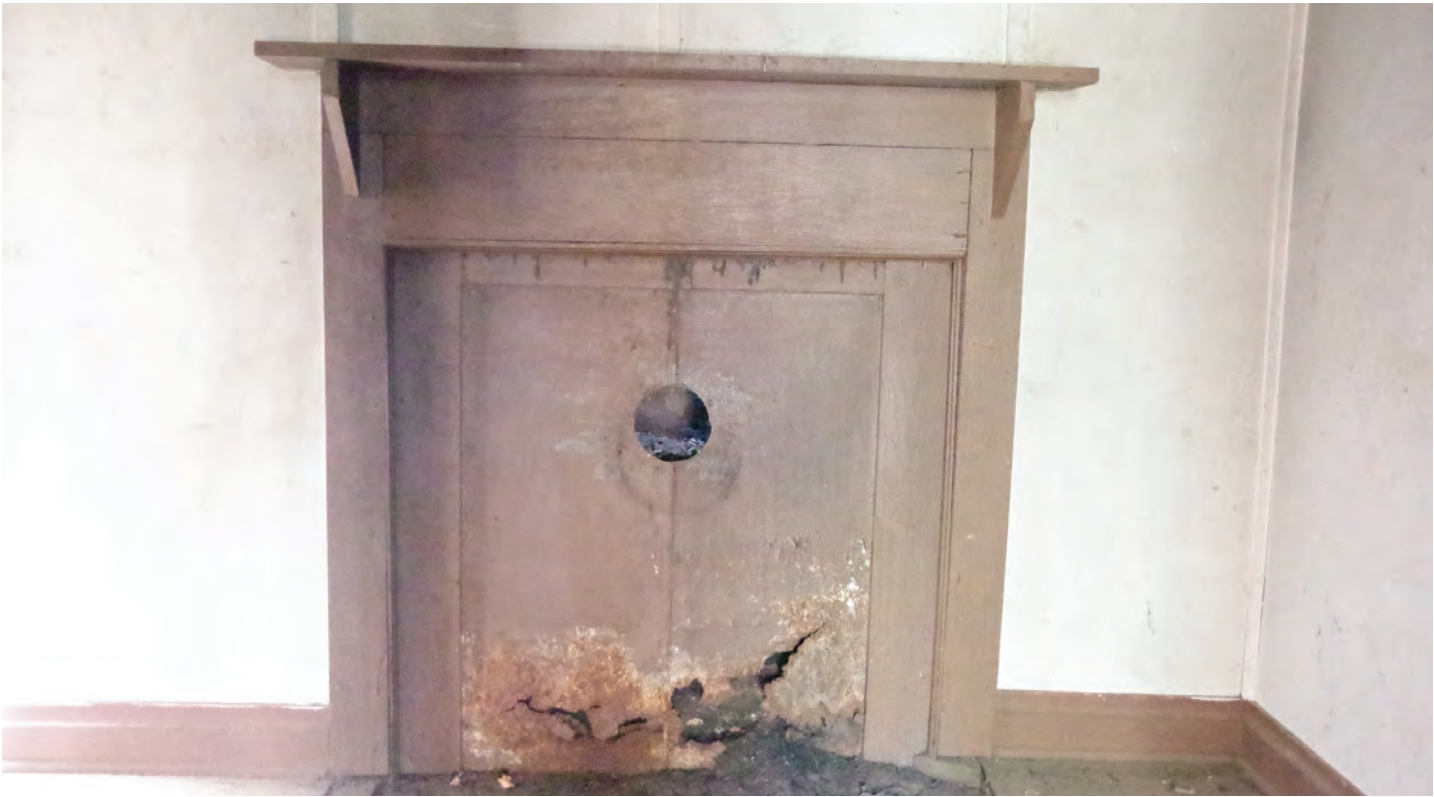
Painted mantel with infill and rustication of metal sheet

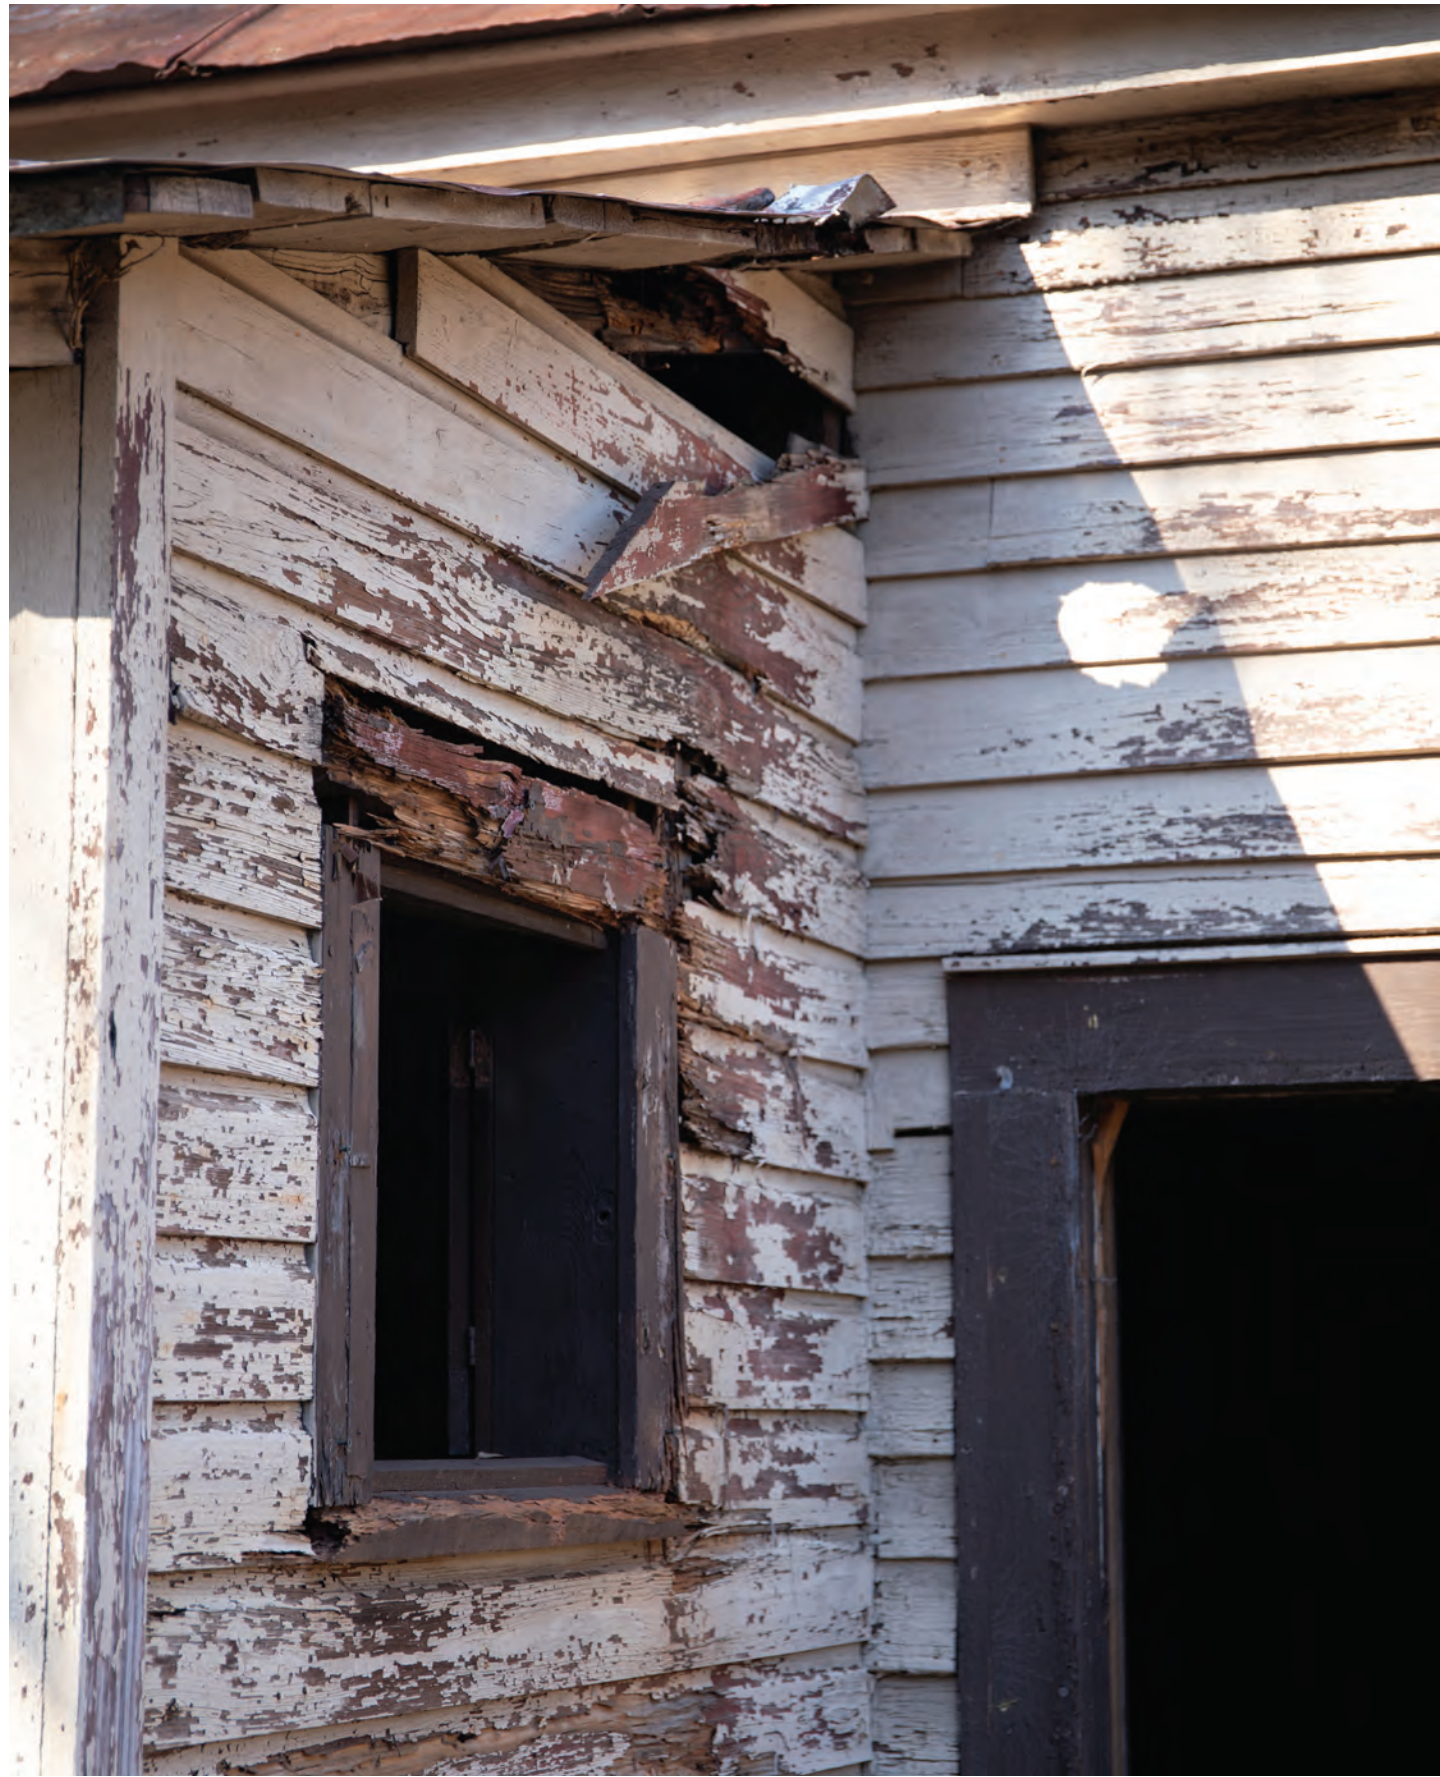
Shed-roof addition, eave and fascia detail, missing sash in addition window opening

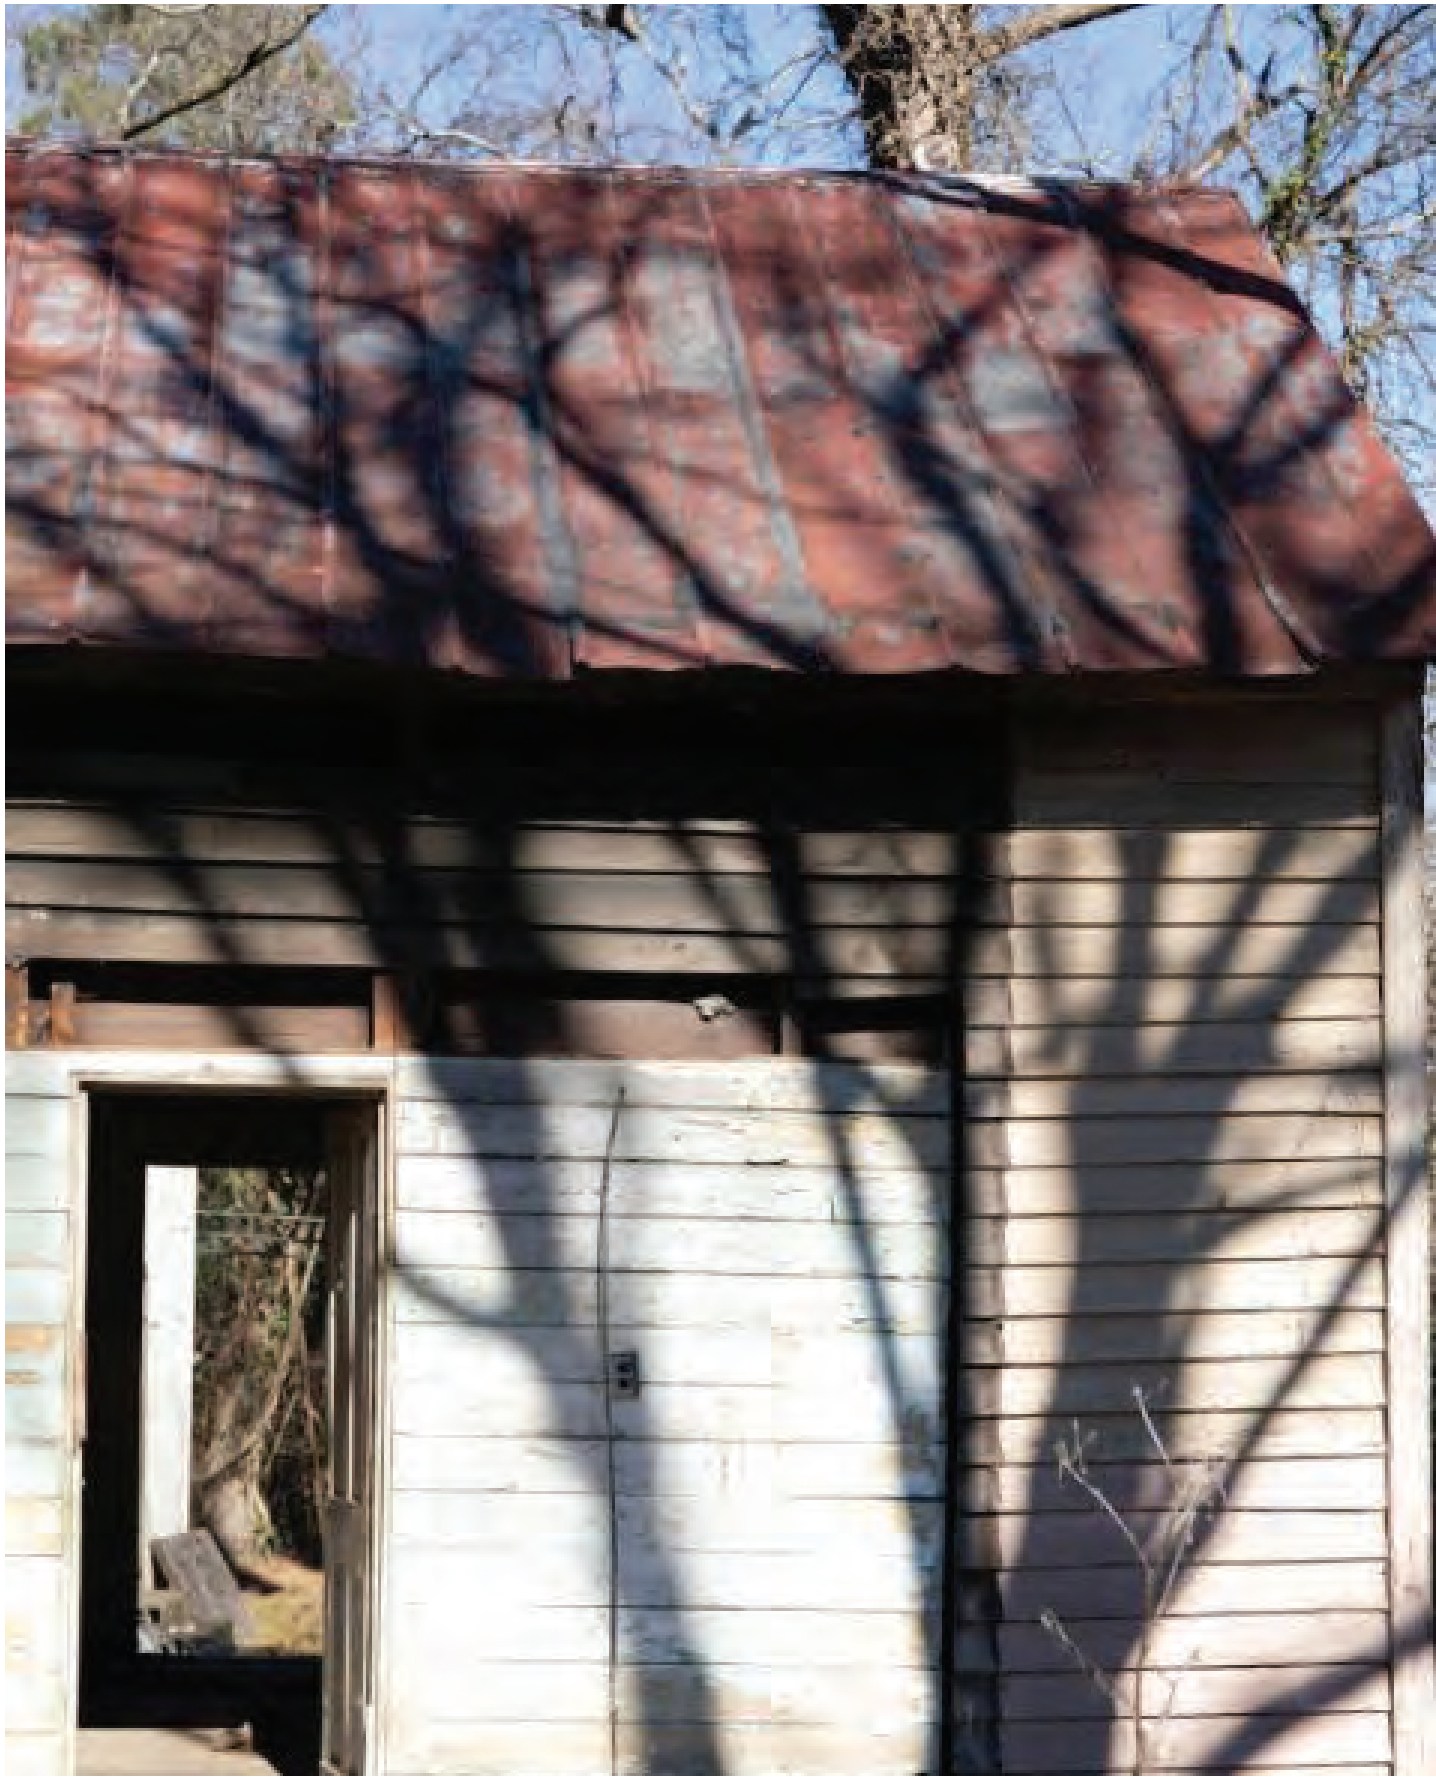
Metal seam roof and remnant of addition on the south facade

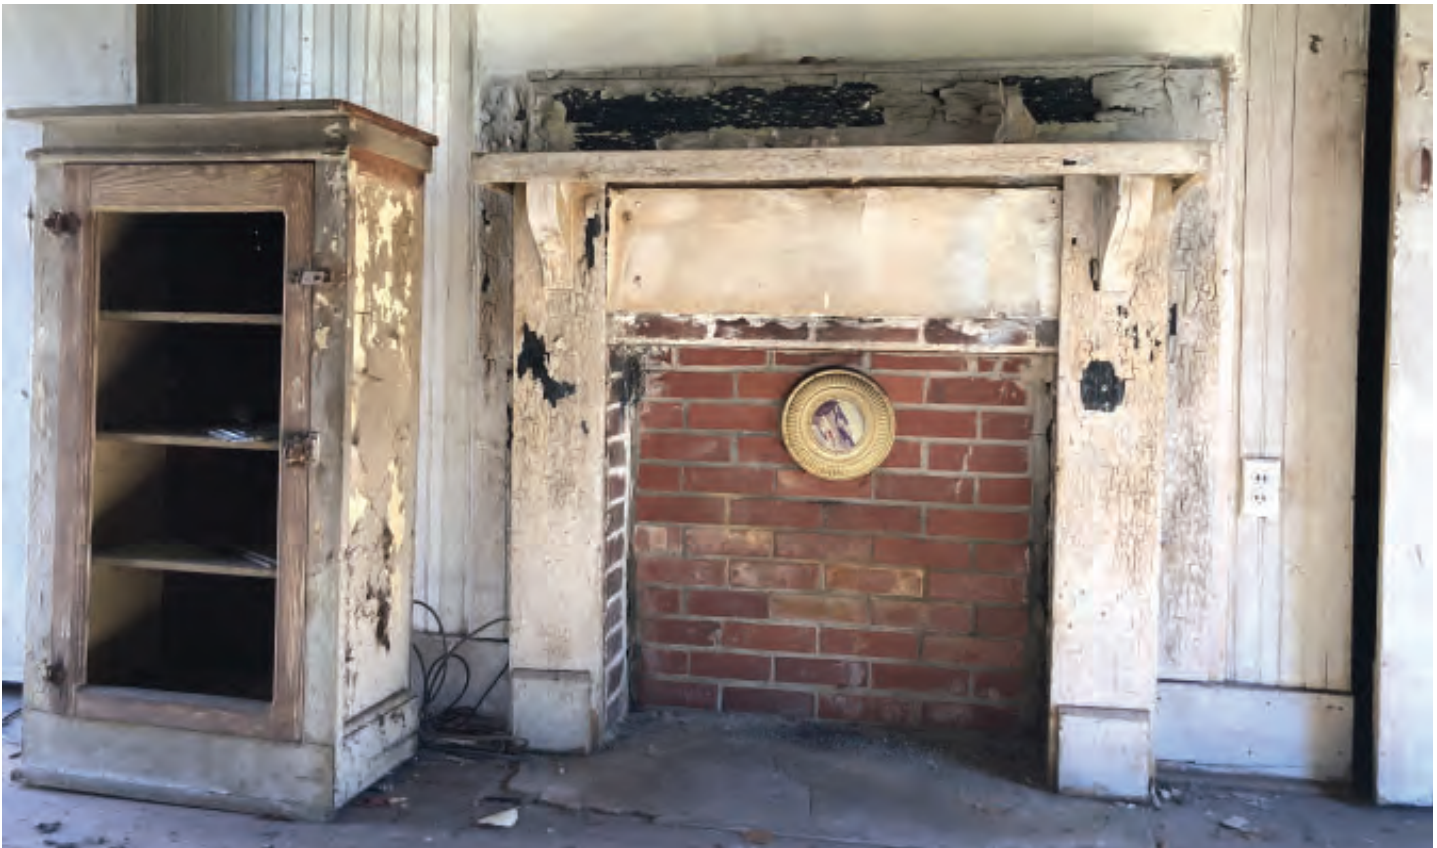
West room architectural piece and fireplace with extruded brick infill

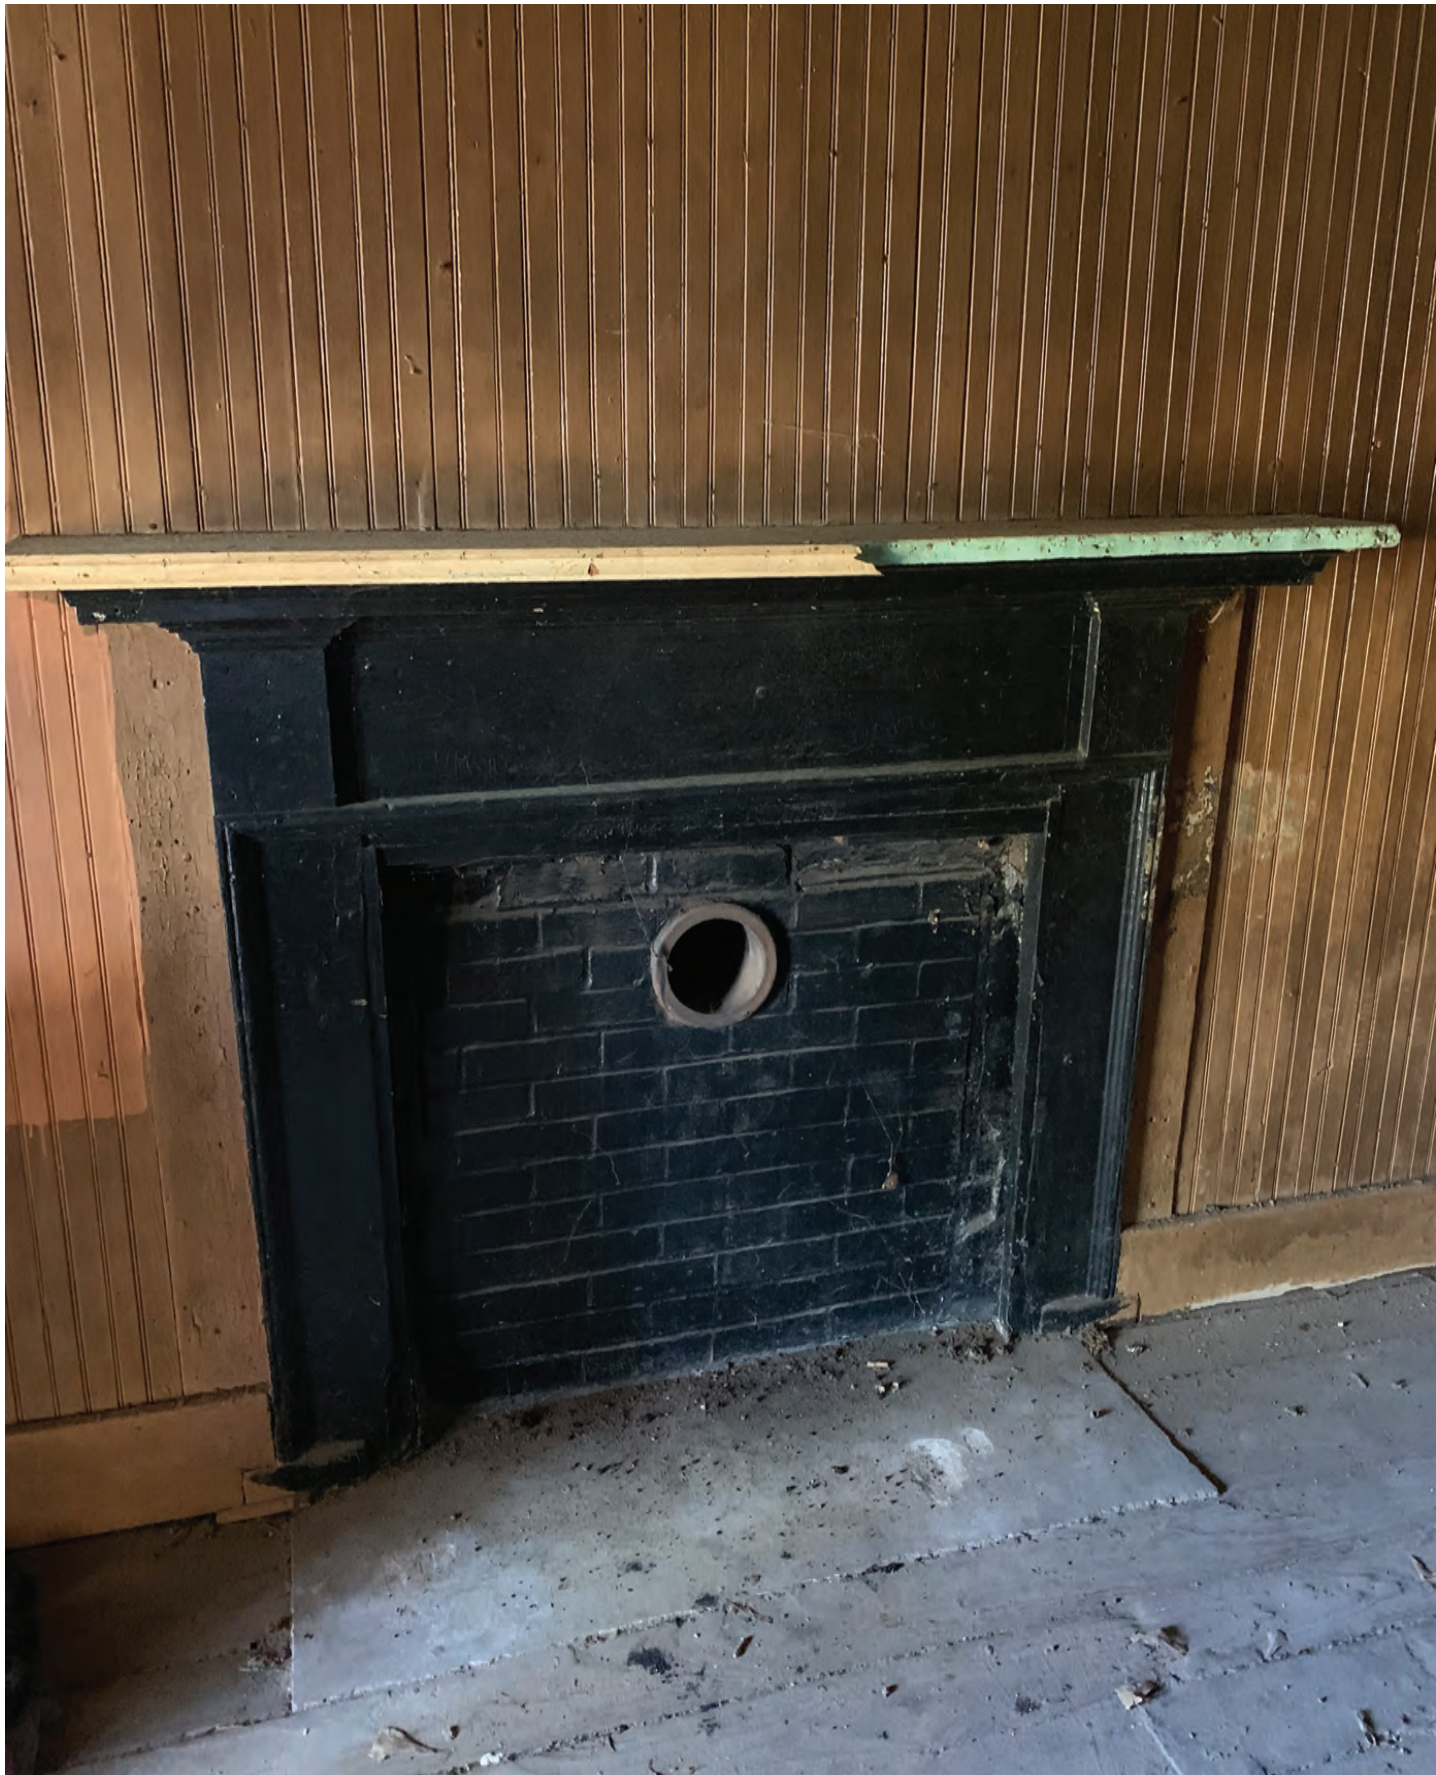
Mantel with brick infill and painted beadboard siding

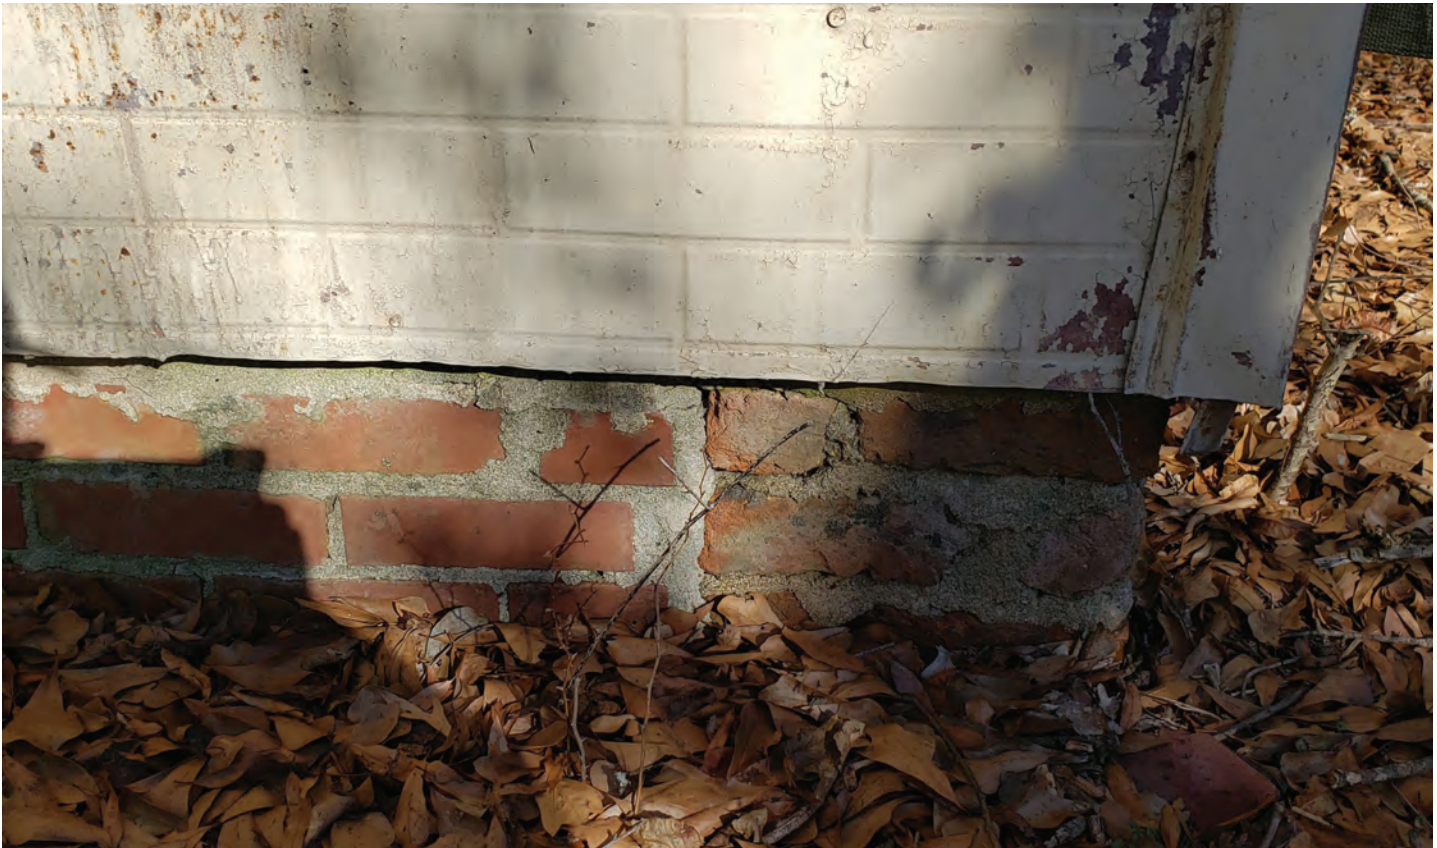
Brick pier foundation with extruded brick and portland cement mortar infill

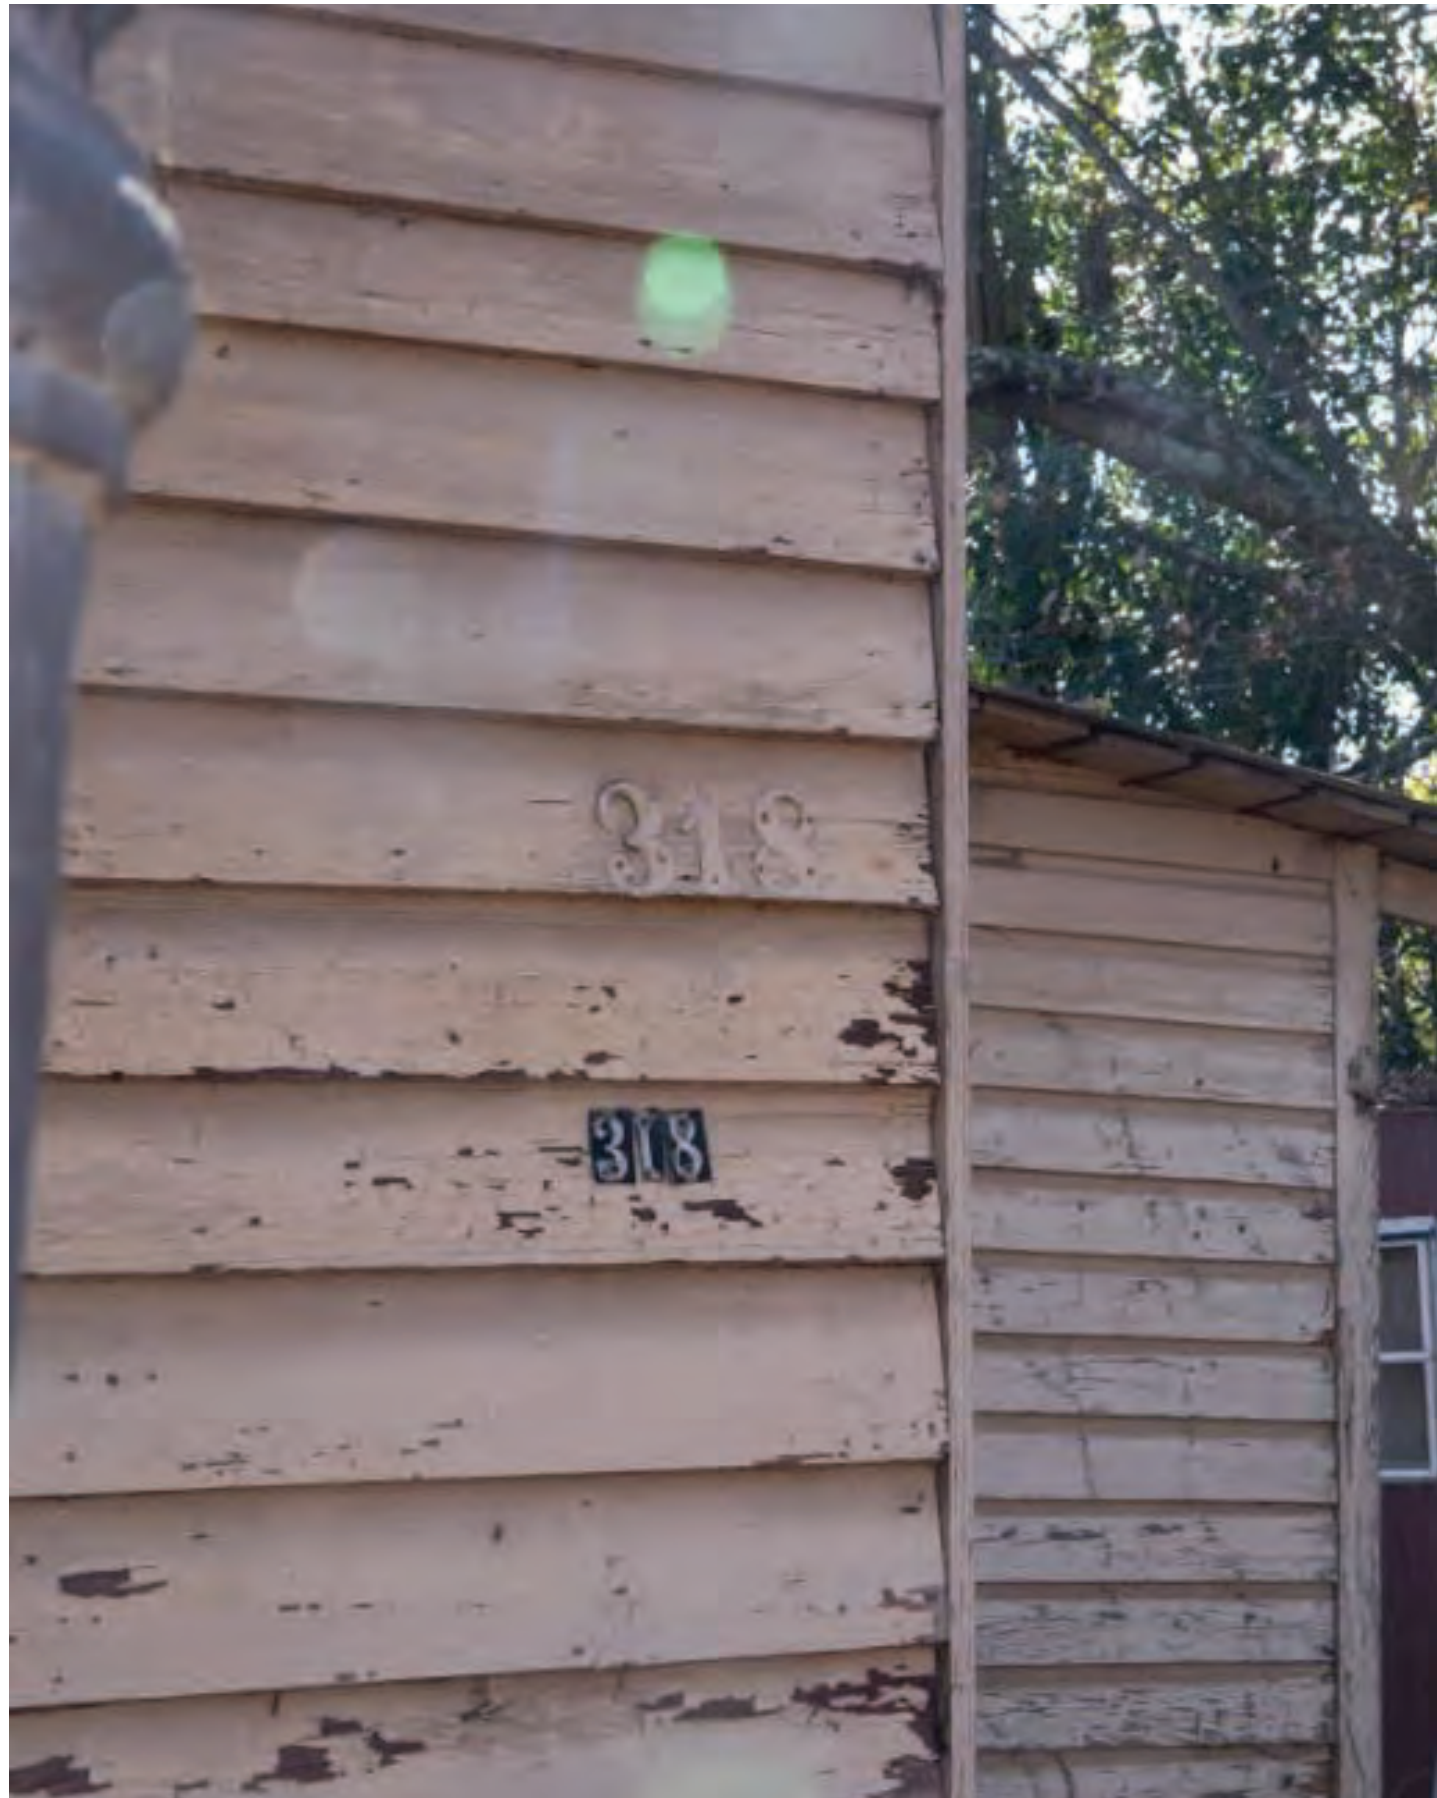
Various siding used on original building and bathroom addition

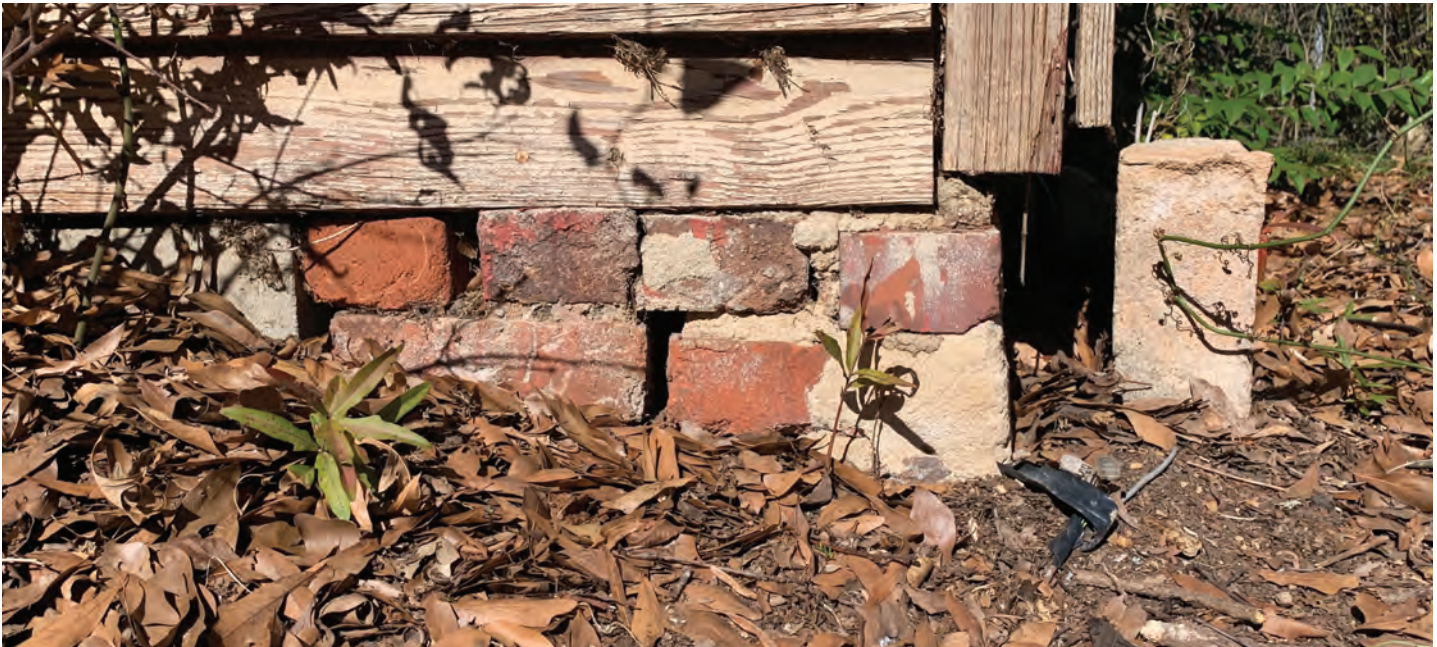
Brick pier foundation at southeast corner, utilizing both hand-molded and extruded bricks
