**Investigation and Documentation of the  
The Barnard Elliott House  
58 George Street  
Charleston, South Carolina**

Students in the Masters in Historic Preservation at  
Clemson University/College of Charleston Class of 2022

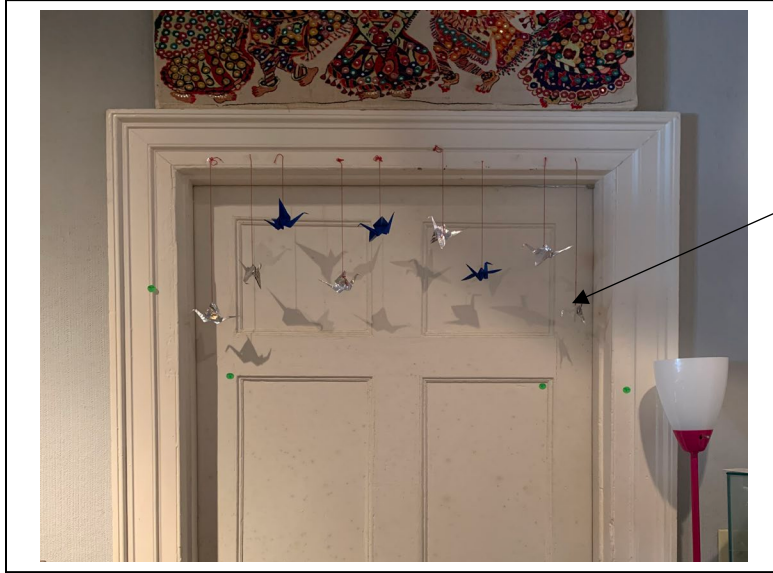
GS1\_FL\_2

Given that this sample also hails from the door surround, it is likely that these are the intact campaigns of paint and the previous sample was an area that had been more heavily stripped of paint. Similar yellows and whites appear alongside brighter colors and more visible dirt lines.

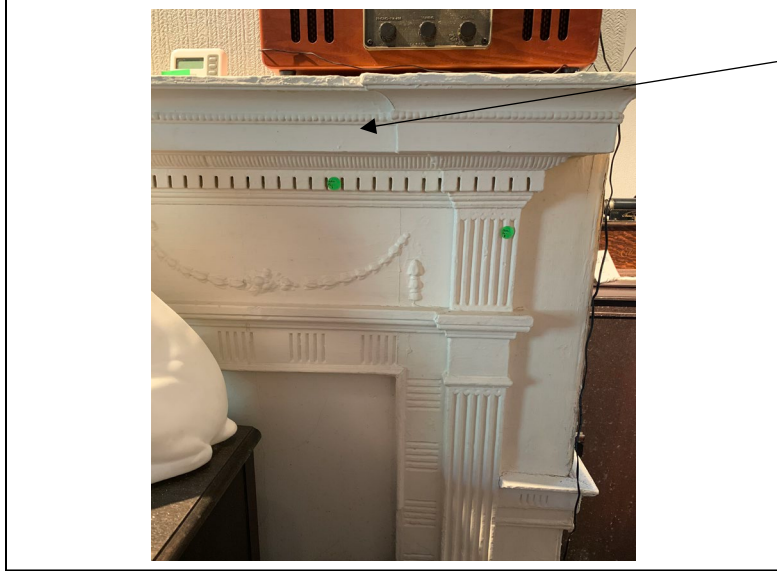
GS1\_FL\_7

This sample, taken from the mantle, includes many interesting layers of almost pearlescent shades of white and cream. A similar campaign of bright paint to that found in the window is present, suggesting these were likely applied at the same time.

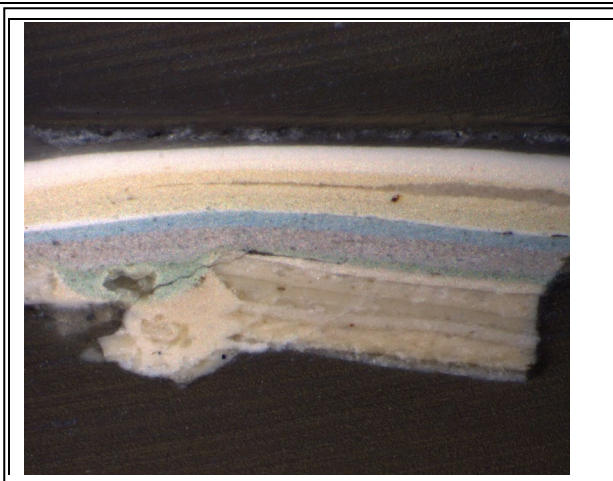
| Paint sample # | Location | Description |
|---|---|---|
| GS1_FL_7 | Mantle | Substrate is followed by a layer of light blue paint similar to that found on the window surround. A brown layer is visible after, possibly a varnish as it appears to be more brittle and different in texture. |

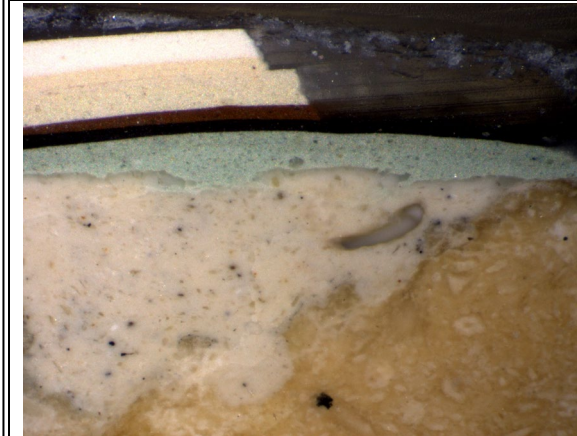
The chair rail includes both the bright colored campaign as well as the possible varnish that was collected at the mantle. These similarities suggest continuities in paint campaigns and also reflect possible treatments on the wood such as the application of varnishes.

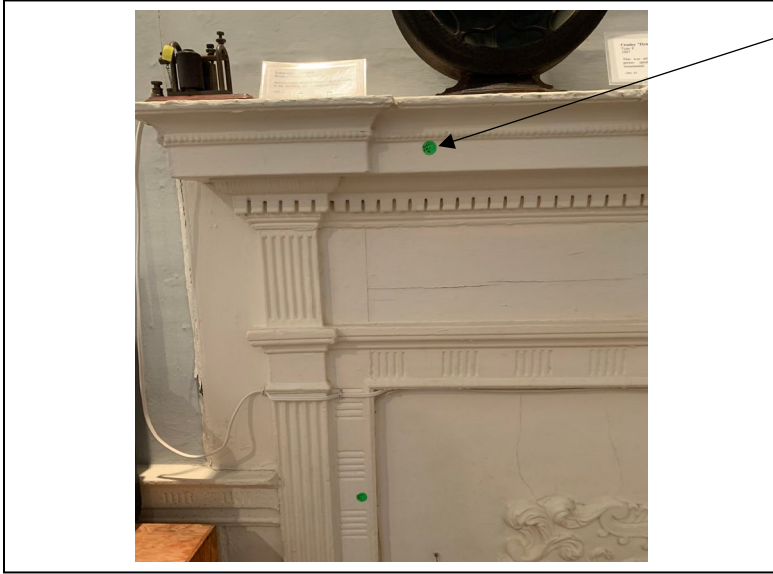
GS1\_FR\_7

| Campaign # | Layer description (starting from substrate): | Notes (color name , texture, inclusions): |
|---|---|---|
| 1 | 1 Paint | Crackled, pale yellow color with many striations and unevenness. Benjamin Moore 2153-70 |
| 2 | 2 Paint | Dark brown layer, possibly similar to the varnish layer found on the FL mantle. Benjamin Moore 2103-10 |

The mantle has some of the most complex layers of paint including possible varnish and possible graining. The addition of a light blue makes its stratigraphy unique. This mantle may have been an addition from an even older property, or at the very least original to this structure and largely unstripped of paint campaigns.

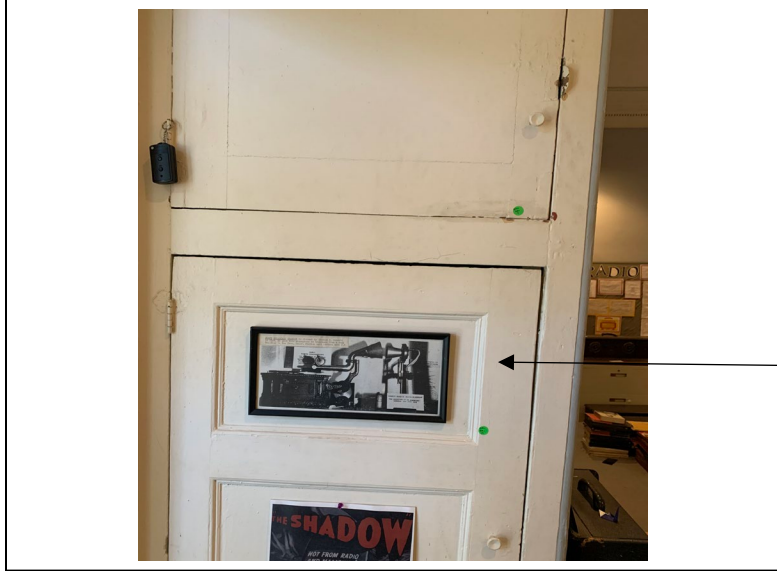
GS1\_FR\_10

| Campaign # | Layer description (starting from substrate): | Notes (color name , texture, inclusions): |
|---|---|---|
| 2 | 2 Paint | Pale yellow paint with some dark inclusions and some visible cracking. Benjamin Moore 2153-70 |

This sample had the most numerous layers out of any sample taken. It is likely that the closet door this was taken from is original to the house and was not stripped of paint before the application of subsequent paint campaigns. Evidence of graining and the use of bright colors are mixed with the typical shades of white and cream. This sample clearly shows the evolution of paint technology, as layers go from grainy with many inclusions to relatively smooth.

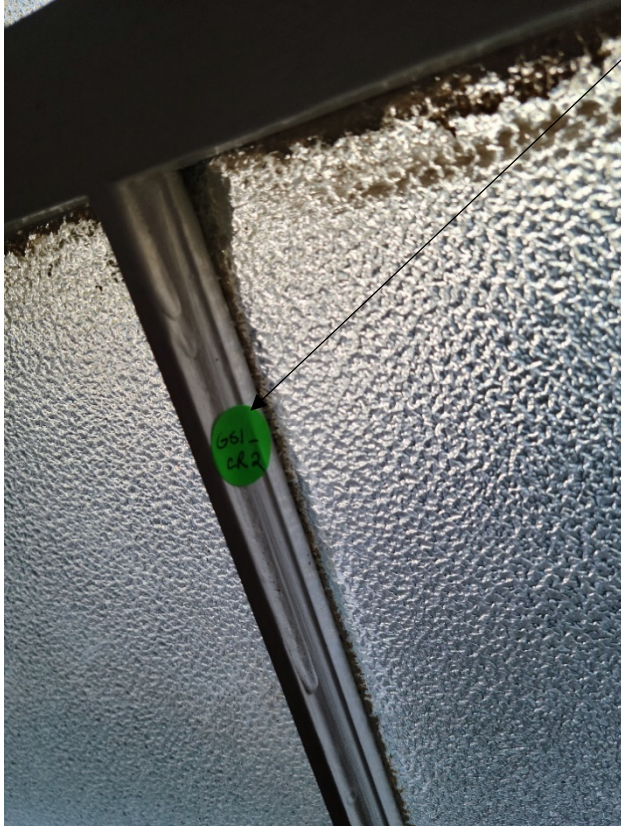
GS1\_CR  
2

Analysis: Some of the same colors in this sample are similar to the sample which came from the wall. However, this sample which came from a window has more layers before. It is possible, therefore, that the windows to the addition were taken from someplace else as the addition was built.

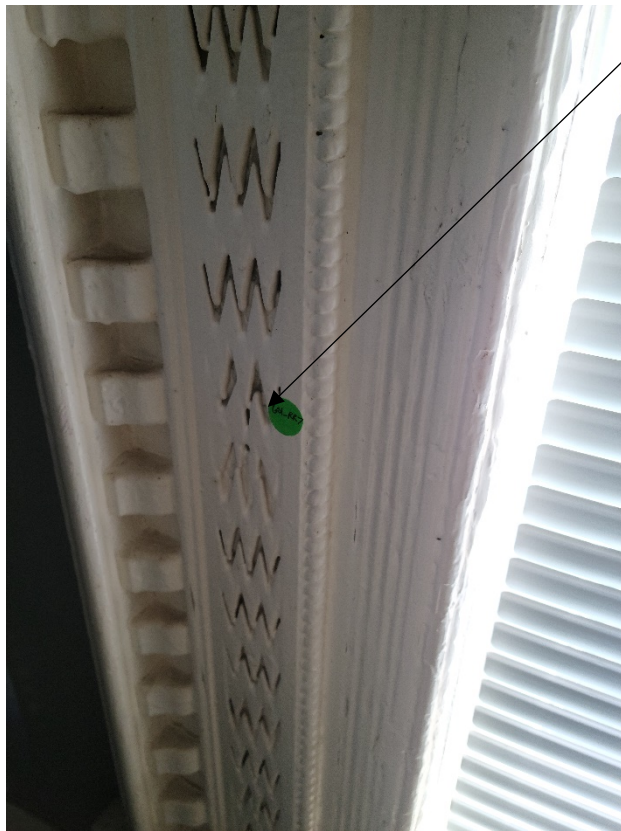
GS1\_RR  
7

Analysis: This paint sample exhibits the same yellow and white colors found in other samples in this room but has several other layers of color before these. This supports the hypothesis that the window trims came from another building.

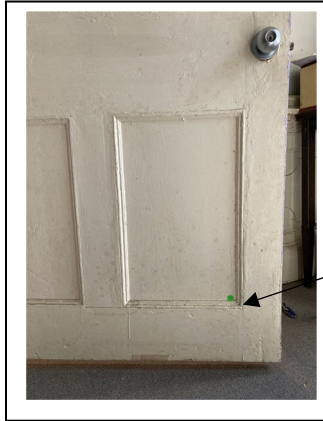
GS1\_H\_5

Analysis: The layers within this sample begin with wood as the substrate. The following layers are distinct and straight. They are relatively close in size except for the yellow shade of paint that is newer. The two shades of red paint may be evidence of wood graining.

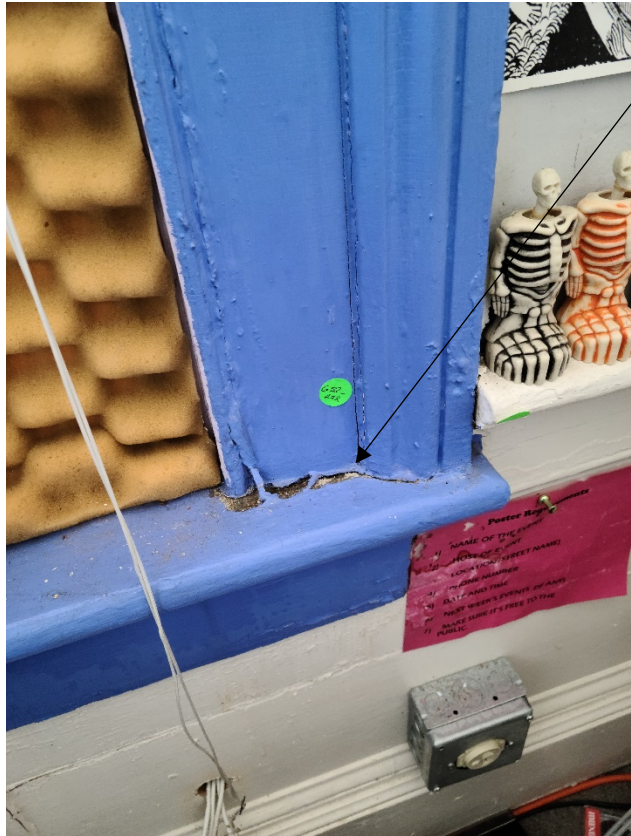
GS2\_RR2

Analysis: This sample has a lot of layers, especially for an addition room. It is possible that this window frame came from another building. The mint green is similar to paint found in another sample, but the later, brighter green, is unique to this sample.

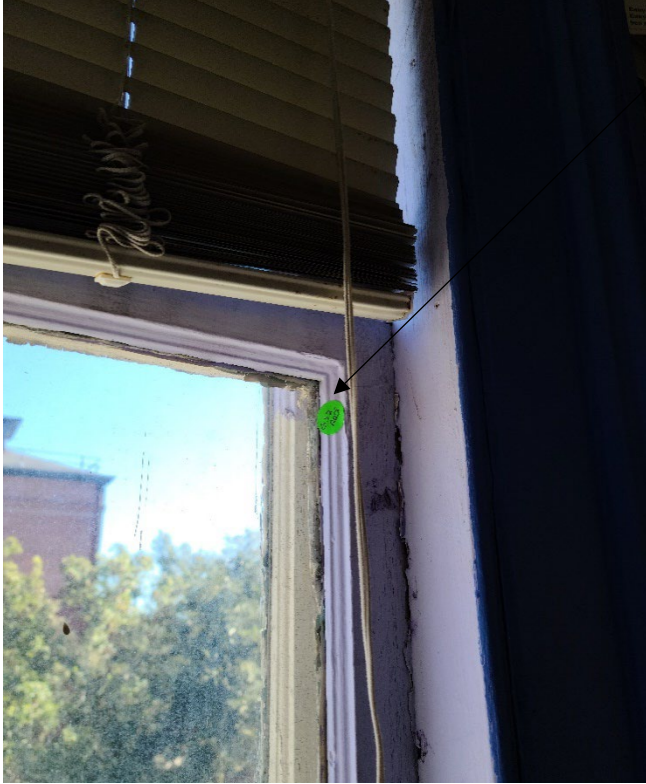
GS2\_RR3

Analysis: This sample has the same yellow with large inclusions found in several other samples.

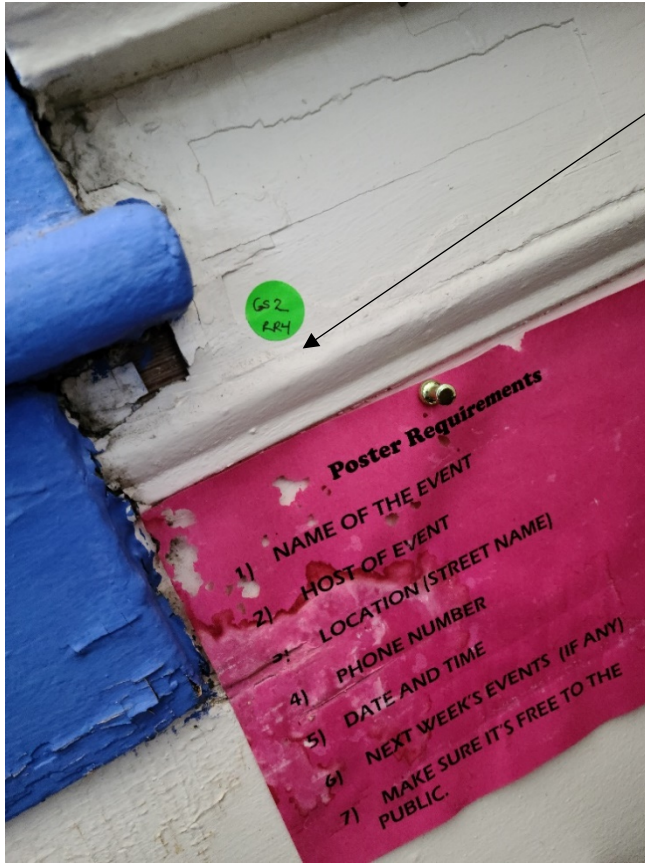
GS2\_RR4

Analysis: This sample has incredibly similar layers to that of the window frame in the same room. Since this came from the wall, near the chair rail, this shows that the windows and the trimmings of the room were similar colors. There also might have been some faux-marbling done.

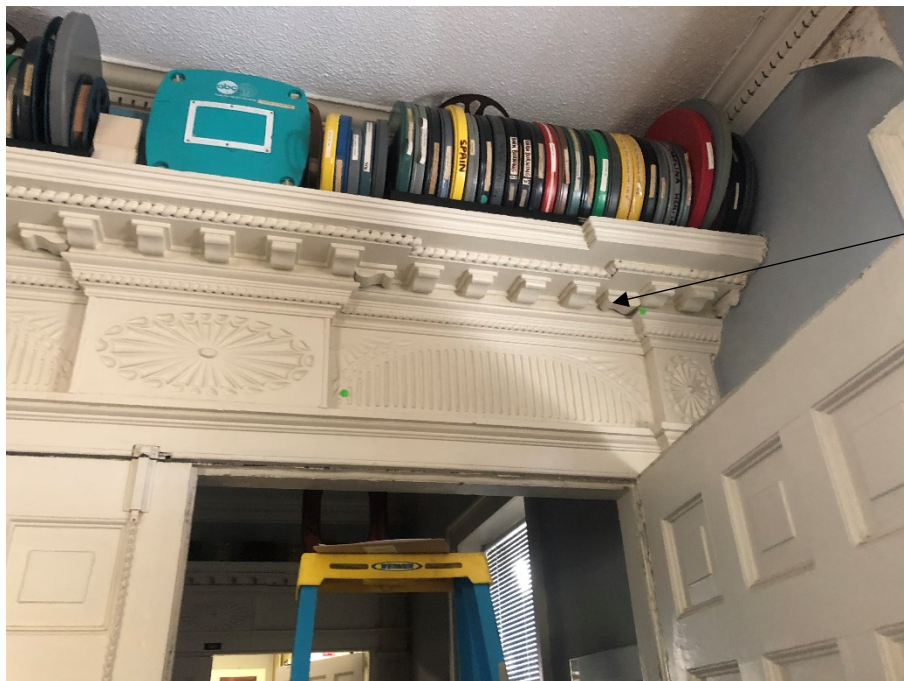
GS2\_FL2

Analysis: Relatively thin layers of colored paint, mixed with thicker layers of whites and yellows. Most layers contain inclusions. Colors taken from Benjamin Moore Color Preview.

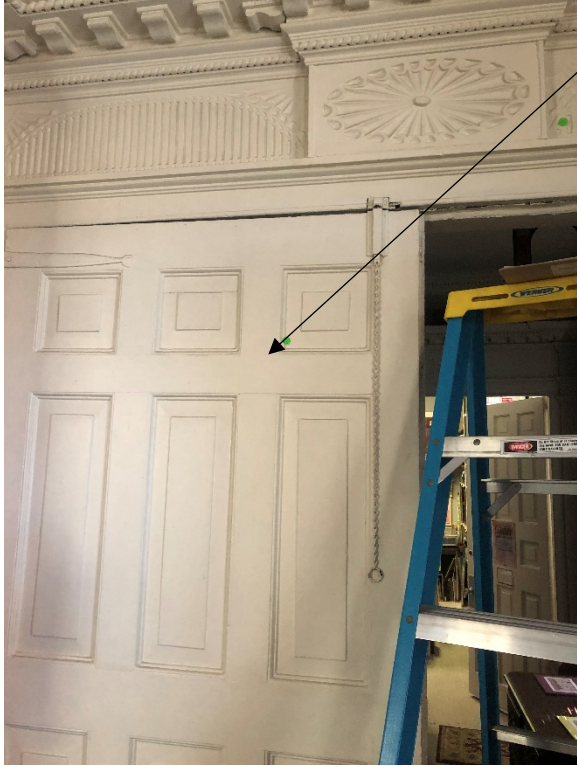
GS2\_FL3

Analysis: Paint consistent in pattern with samples taken from similar location. Campaigns are thick with clear edges. Paint colors taken from Benjamin Moore Color Preview.

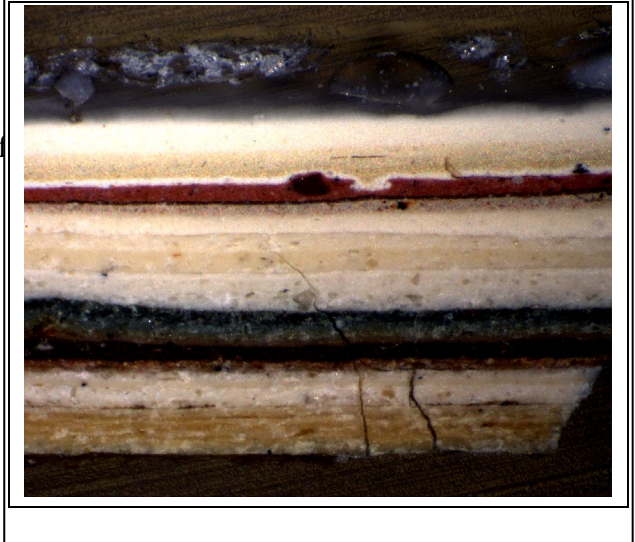
GS2\_FL6

Analysis: Sample contains multiple campaigns of graining. All campaigns are relatively thin and uniform. Paint colors taken from Benjamin Moore Color Preview.

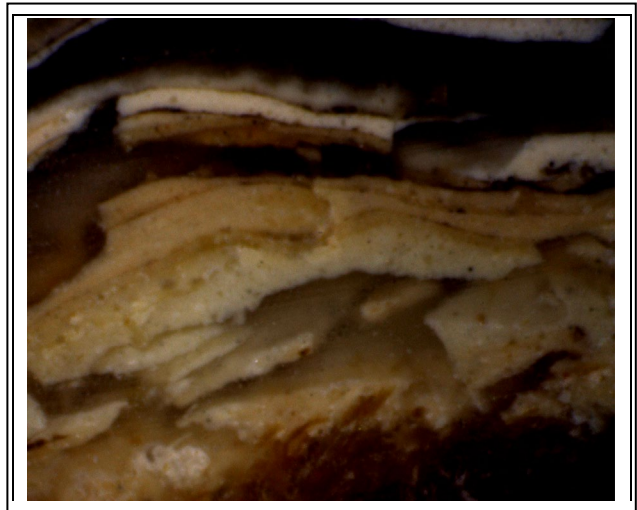
Analysis: Most layers of any sample collected, possible due to the location of the sample; between dentals of fireplace mantle. Two layers of graining present, one wood and another marble. Paint preparation was clearly done to the front face of the mantle, however the area between the dental has seen less preparation, resulting a large number of campaigns being present. Paint colors taken from Benjamin Moore Color Preview.

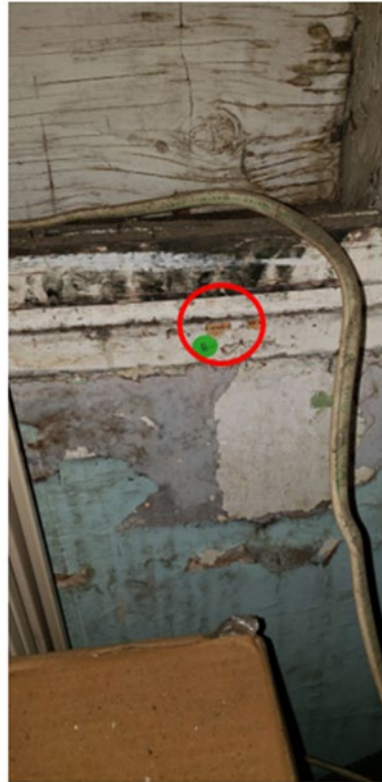
GS4\_FL\_8

Analysis: substrate with 4 layers of historic paint of mostly thin layers and inclusions visible.

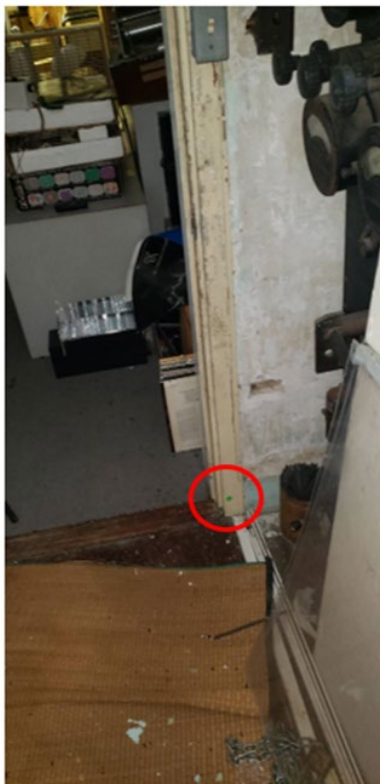
GS4\_FL\_12

| Campaign # | Layer Description (starting from substrate) | Notes (color name, texture, inclusions) |
|---|---|---|
| 2 | Paint -: | Broken layer of light-pink colored paint over cream-colored paint layer. Benjamin Moore 2172-60, smoot consistency, moderate inclusions |
| 5 | Paint + | Broken layer of mustard-yellow paint. Benjamin Moore 2152-50, rough consistency, no inclusions |
| 6 | Paint + | Layer of brown colored paint over broken layer of grey paint. Benjamin Moore 2115-60, broken consistency, high inclusions |

| 10 | Paint -: | Thin layer of light green paint. Benjamin Moore 2033-60, broken consistency, moderate inclusions |
| 12 | Paint -: | Broken layer of off-white paint. Benjamin Moore 2144-60, smooth consistency, moderate inclusions |

Analysis: sample with substrate and 11 layers of historic paint. Several of the same shades appear.

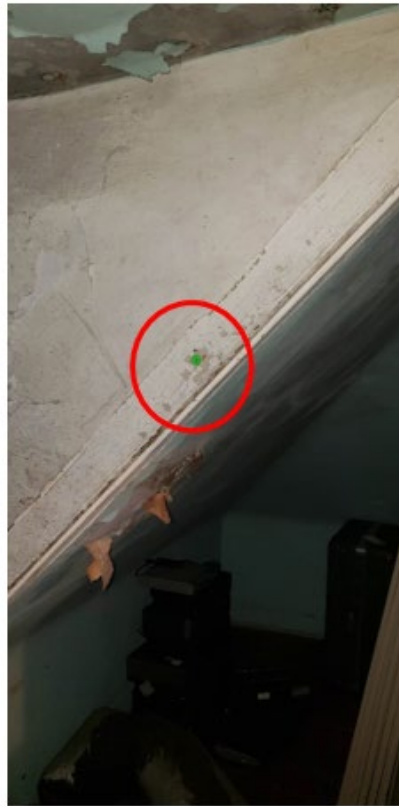
GS4\_FR\_4

| Campaign # | Layer Description (starting from substrate) | Notes (color name, texture, inclusions) |
|---|---|---|
| 1 | Paint -: | Broken layer of cream colored paint over substrate. Benjamin Moore 2153-70, broken consistency, no inclusions |
| 2 | Paint -: | Broken payer of light brown paint. Benjamin Moore 2160-40, broken consistency, moderate inclusions |
| 3 | Paint -: | Thin layer of cream colored paint. Benjamin Moore 2153-70, broken consistency, moderate inclusions |
