# East Morris Street Cottages

312- 318 East Morris Street, Anderson, South Carolina  
Graduate Program in Historic Preservation  
Clemson University/The College of Charleston  
Preservation Studio - Spring 2021

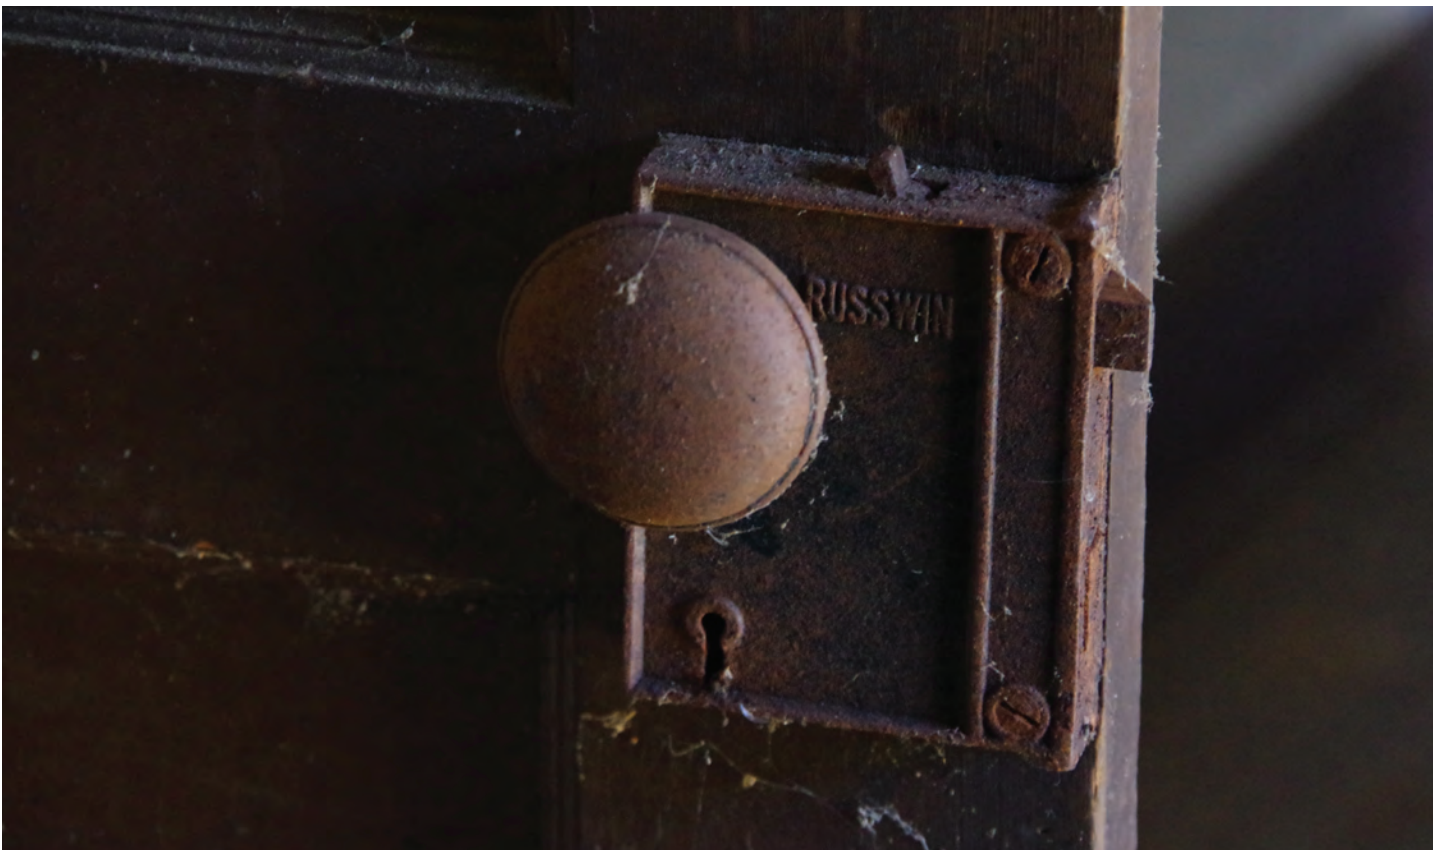
Door knob located on interior door

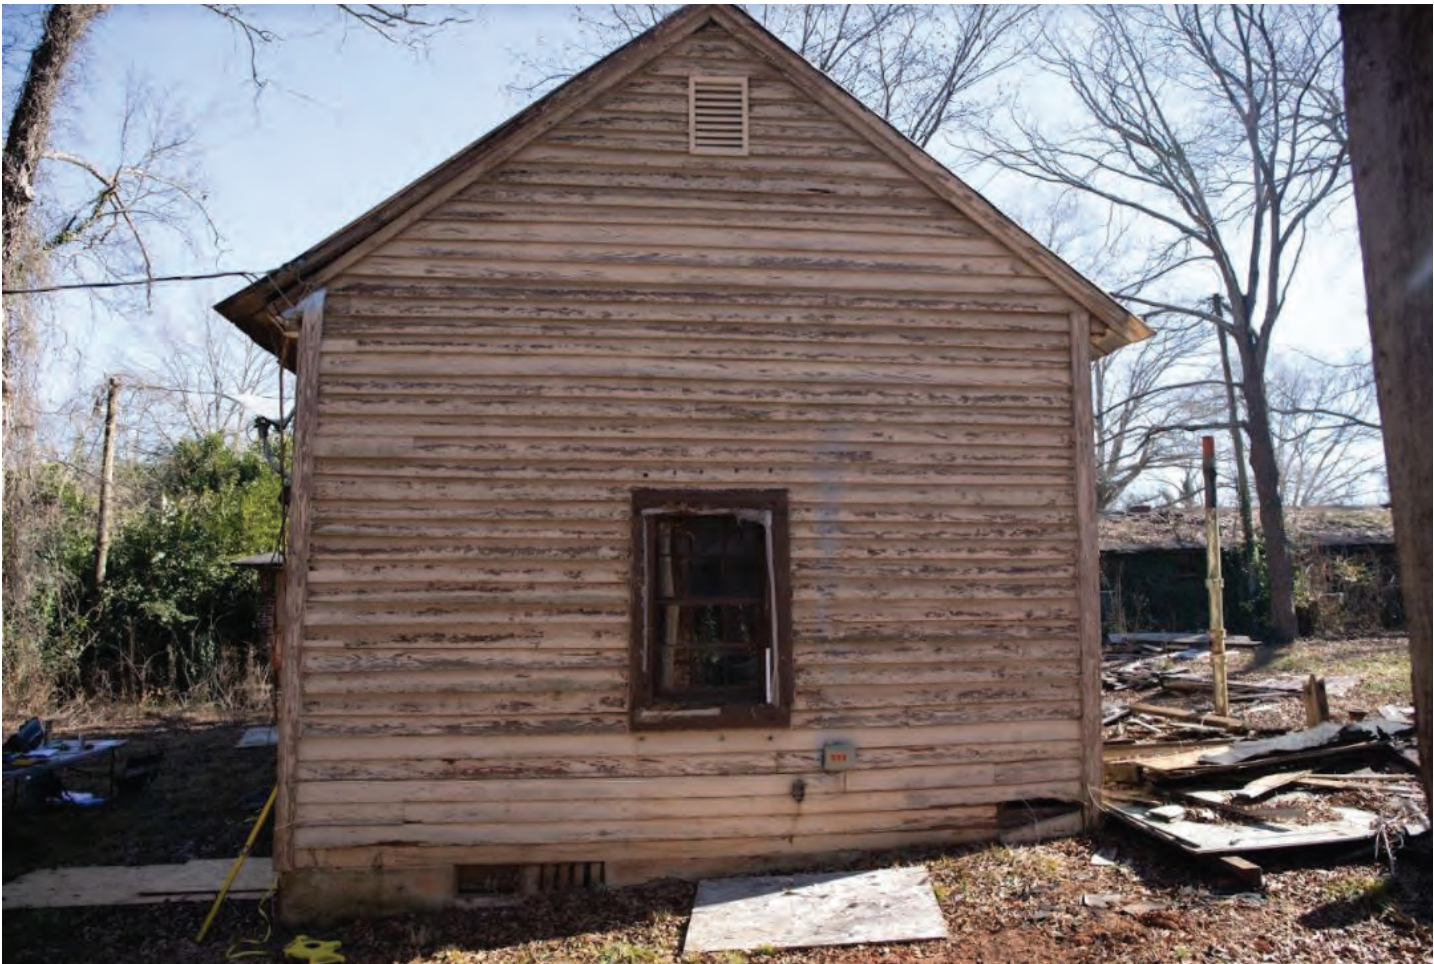
West facade showing sloping topography

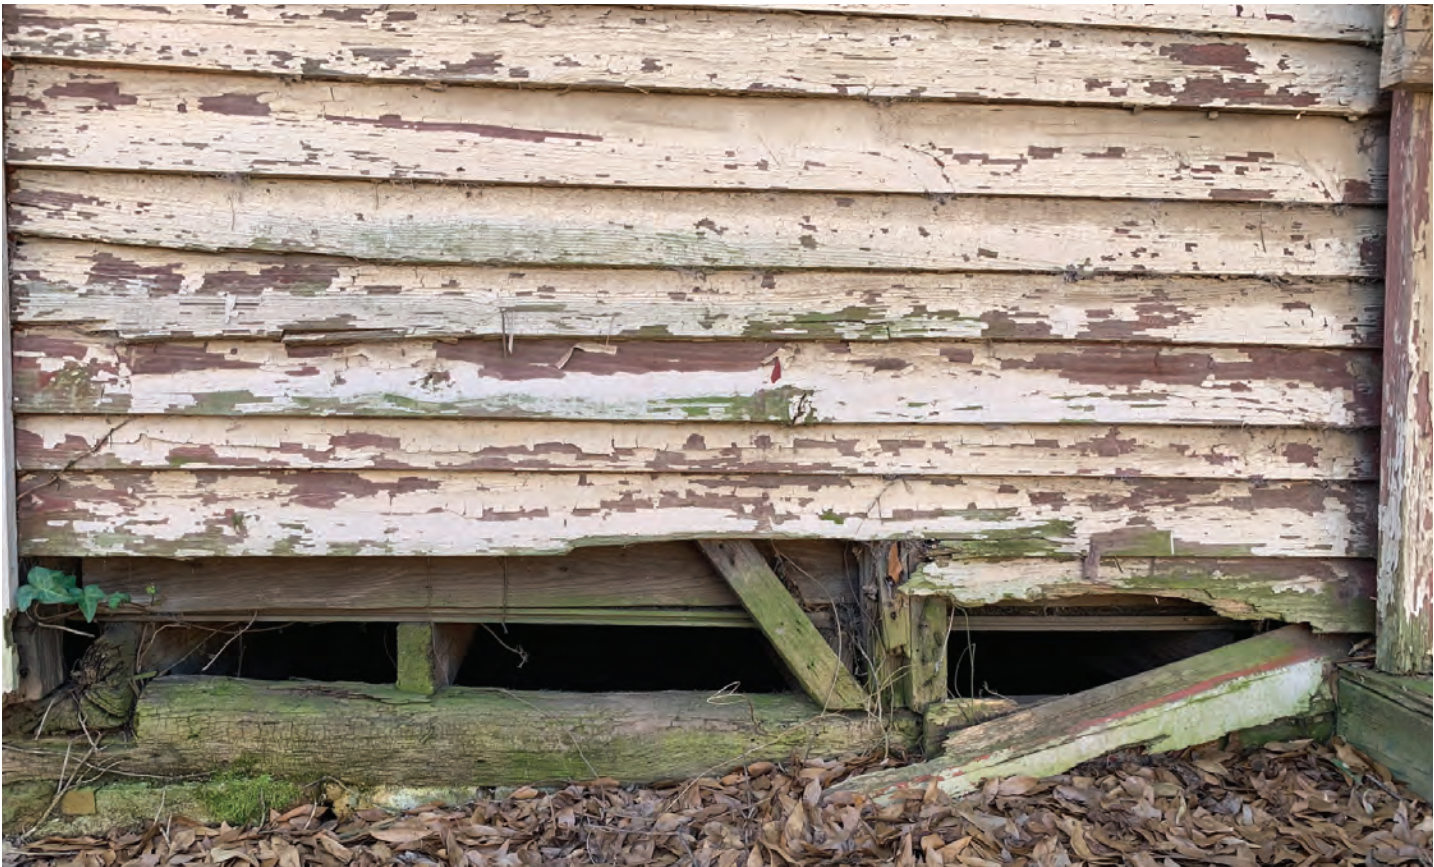
Northeast corner showing diagonal bracing resting on a hand-hewn sill plate

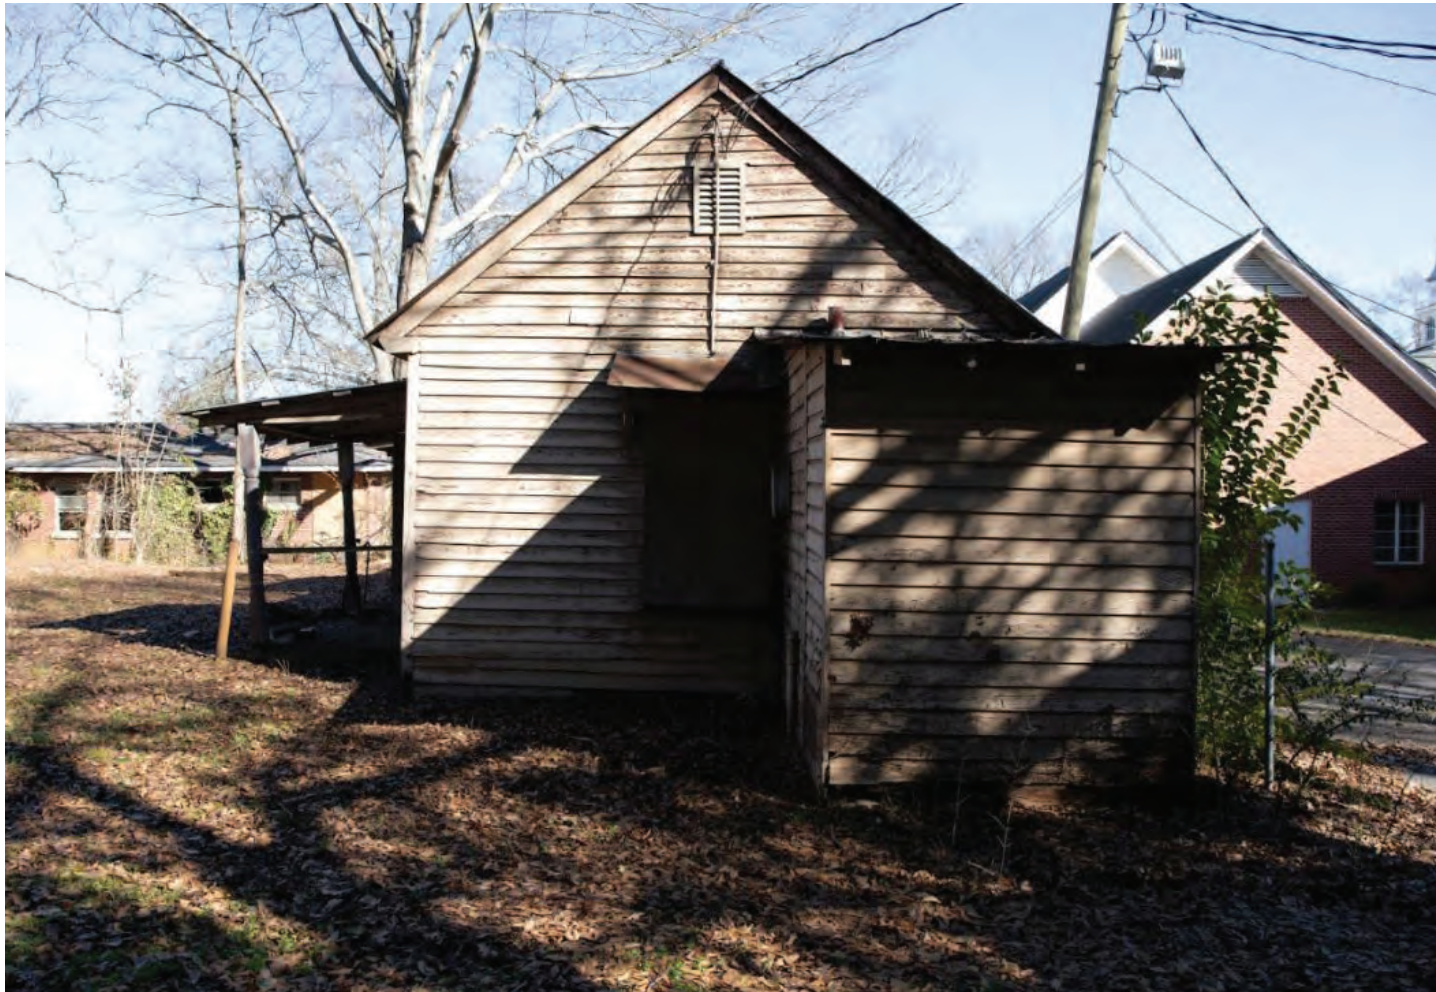
West elevation showing bathroom addition and porches

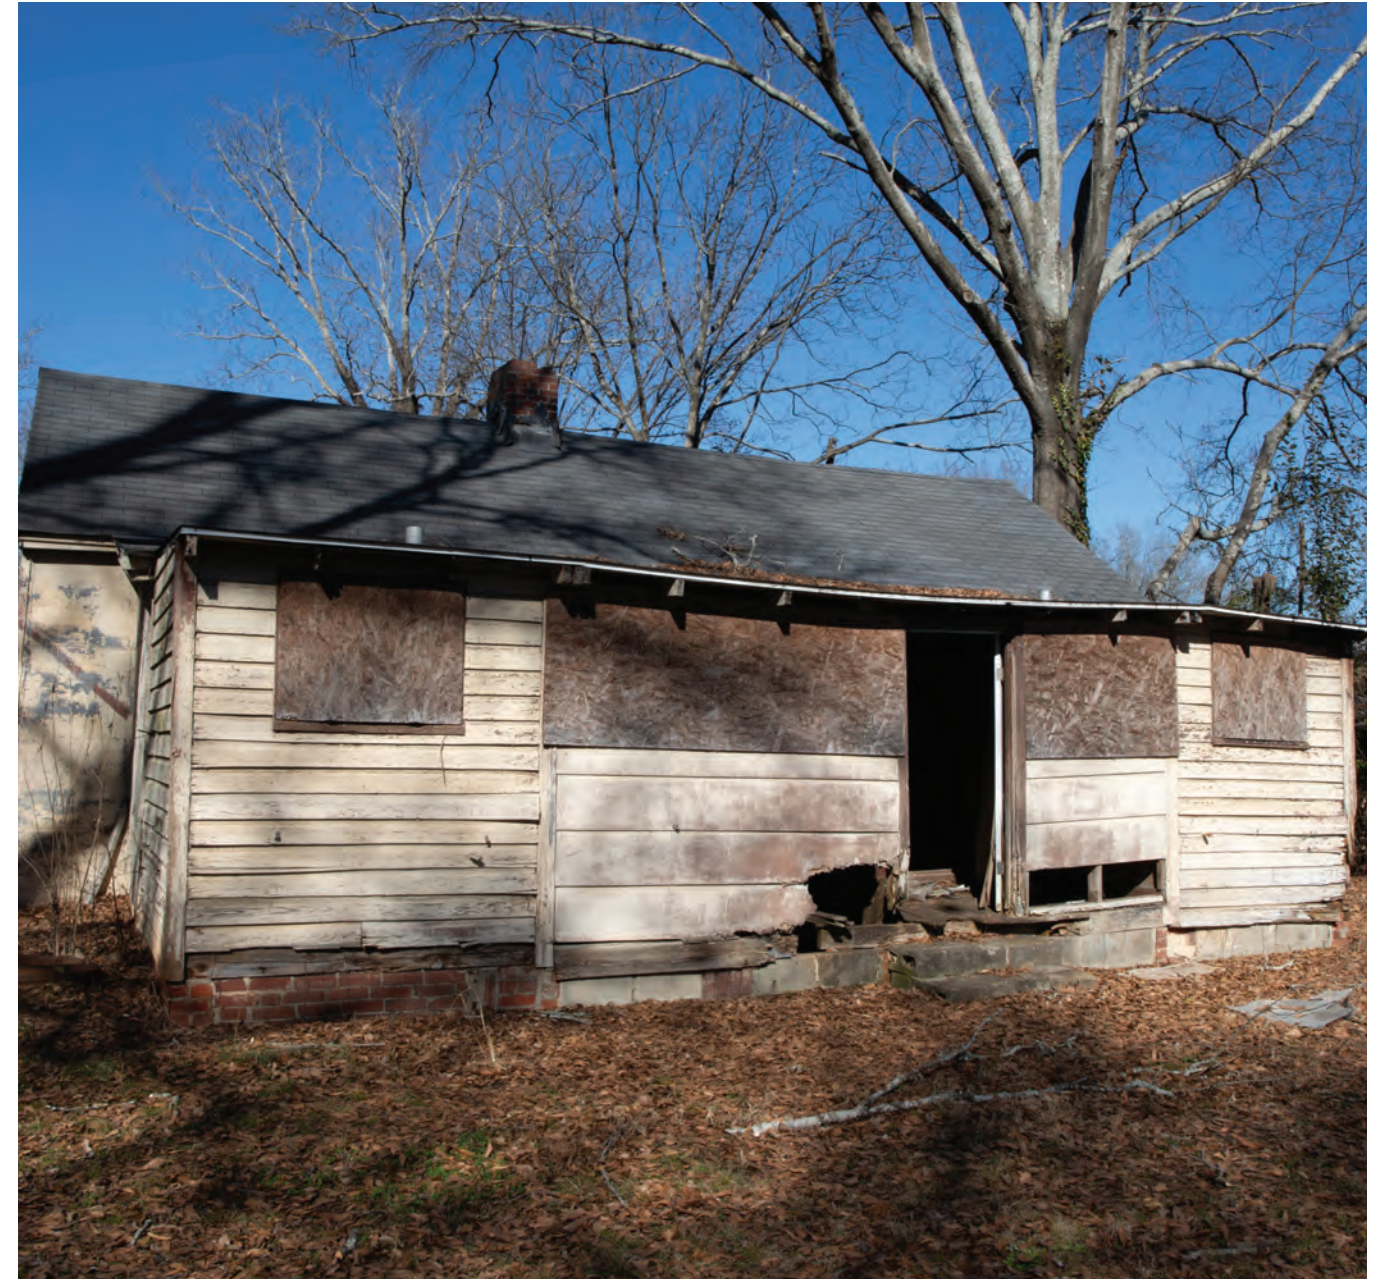
316 East Morris Street, south facade showing additions

Cottage three's south elevation is severely weather-damaged leaving the entry vulnerable to illegal access to the building. The wood composite siding surrounding the doorway currently allows weather and rodent intrusion into the building. Additionally, shade from large trees to the east of the building prevents the exposed wood siding from drying quickly, resulting in further deterioration. It is recommended that failing paint be removed and paint be applied to ensure the protection of weatherboards and reduce moisture saturation of cladding material. The metal siding panels on the original structure are pulling away from the building and need to be reattached if investigation confirms that the panels are problematic. The corner boards of the southern additions have their grain-end exposed to the soil, resulting in significant rising damp and therefore moisture intrusion. These
