# East Morris Street Cottages

312- 318 East Morris Street, Anderson, South Carolina  
Graduate Program in Historic Preservation  
Clemson University/The College of Charleston  
Preservation Studio - Spring 2021

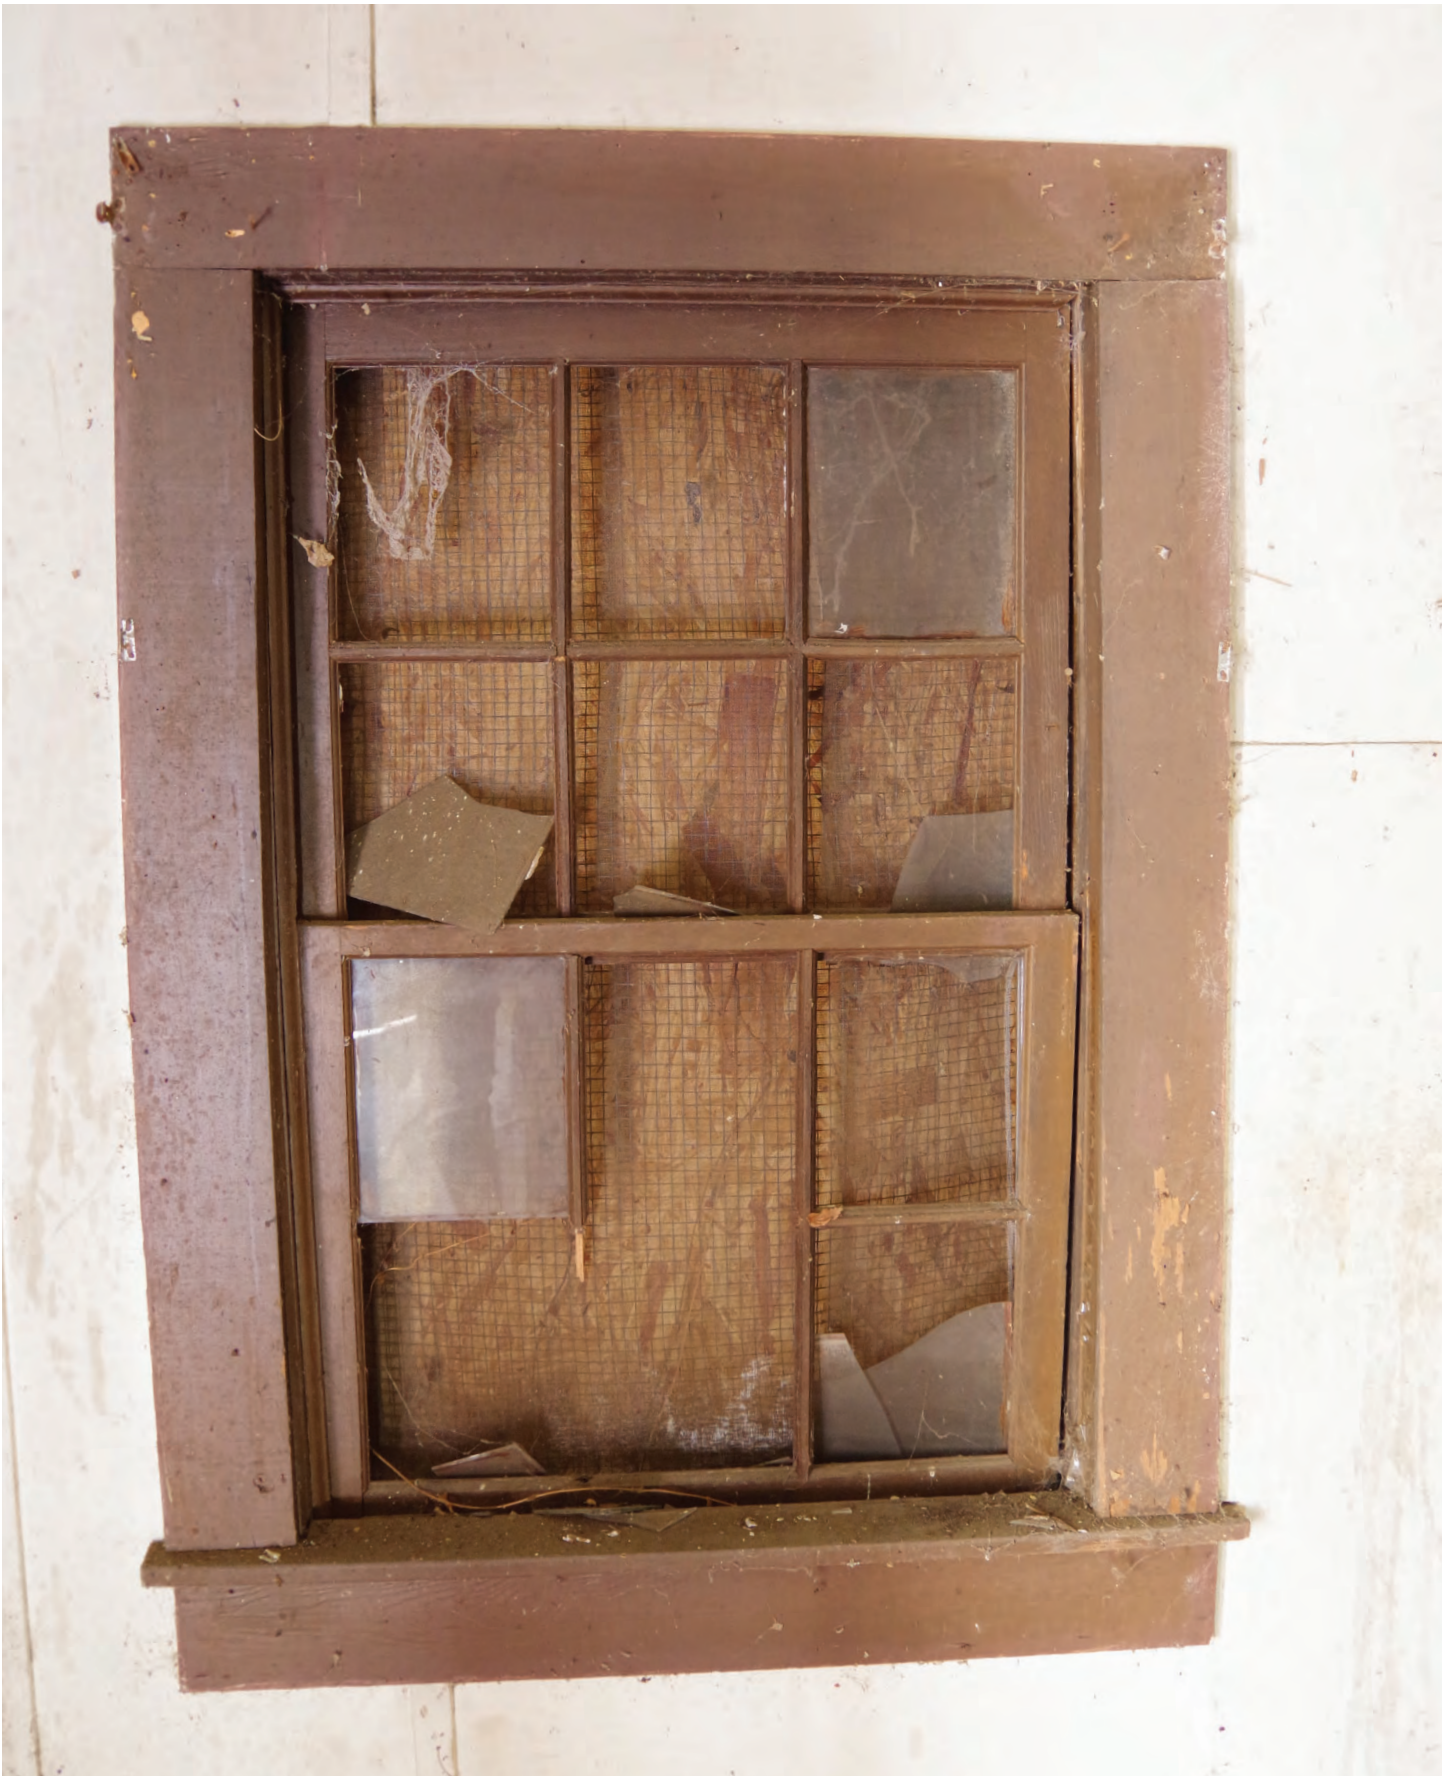
Interior window frame showing six-over-six light frame

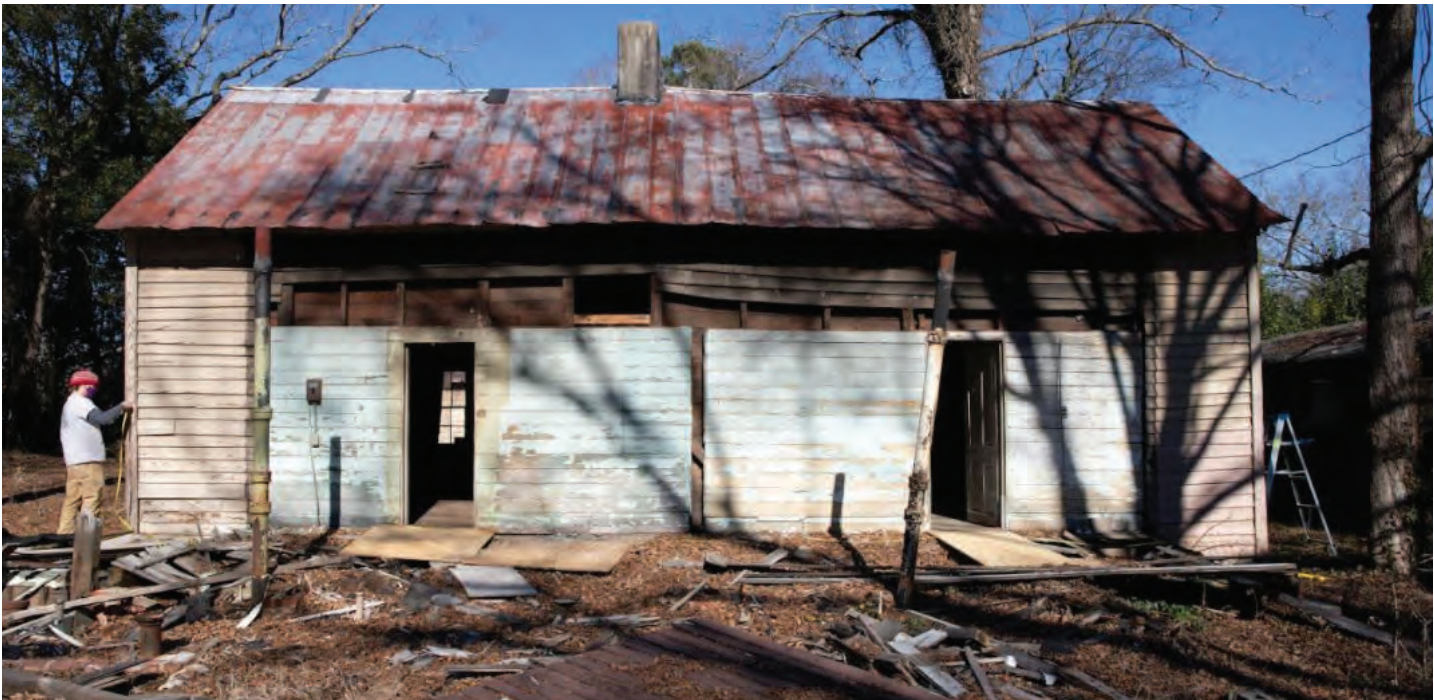
South facade showing remnants of the addition

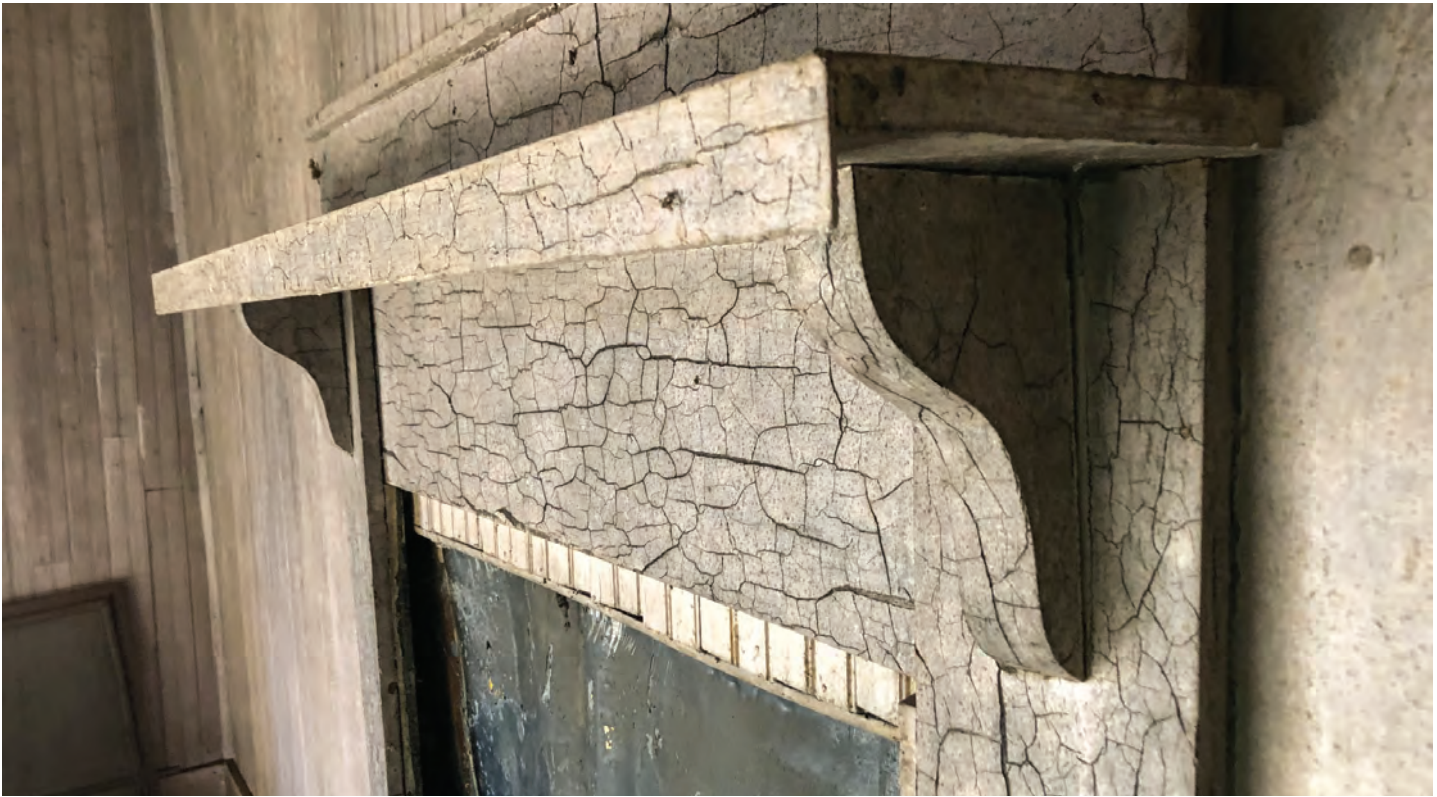
East room mantelpiece

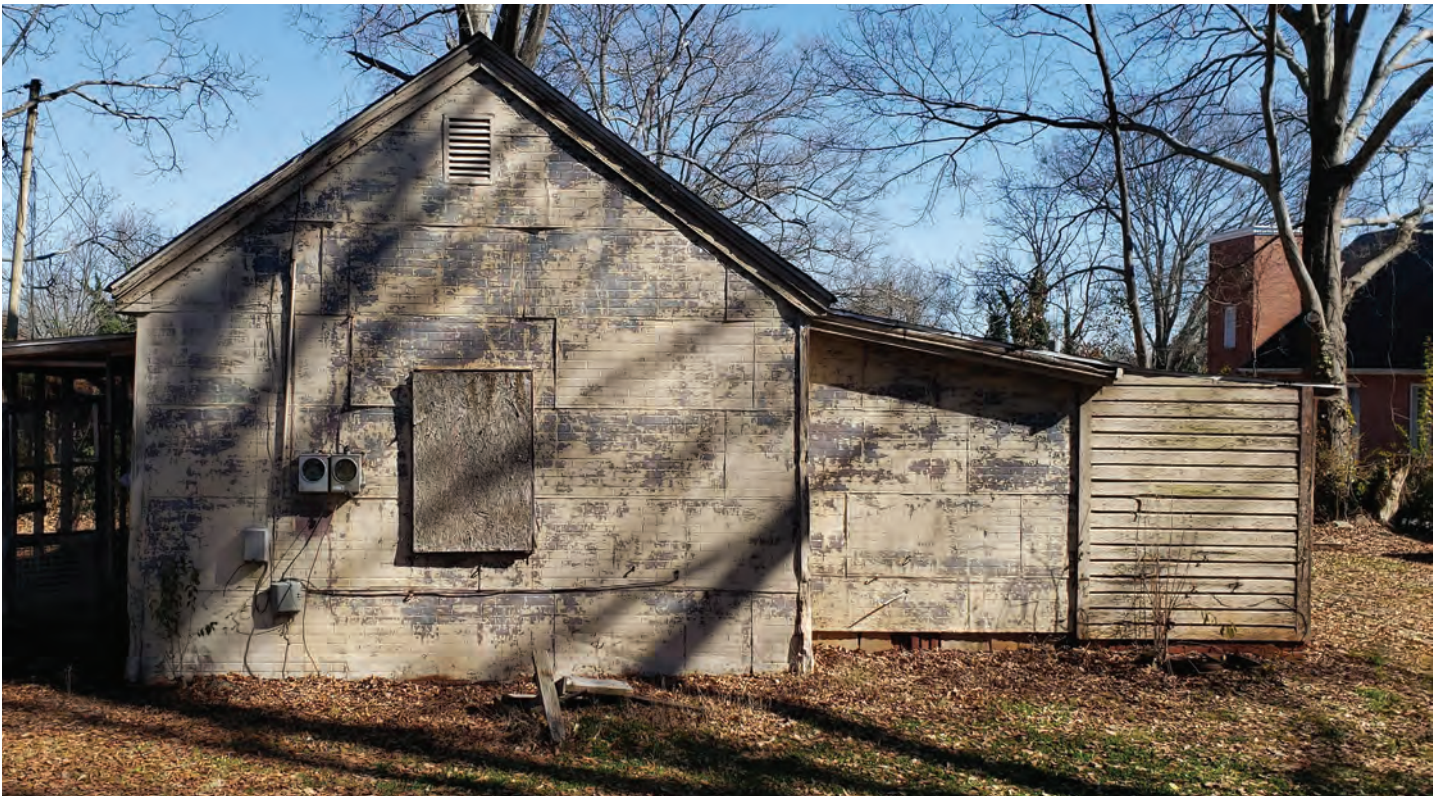
West facade

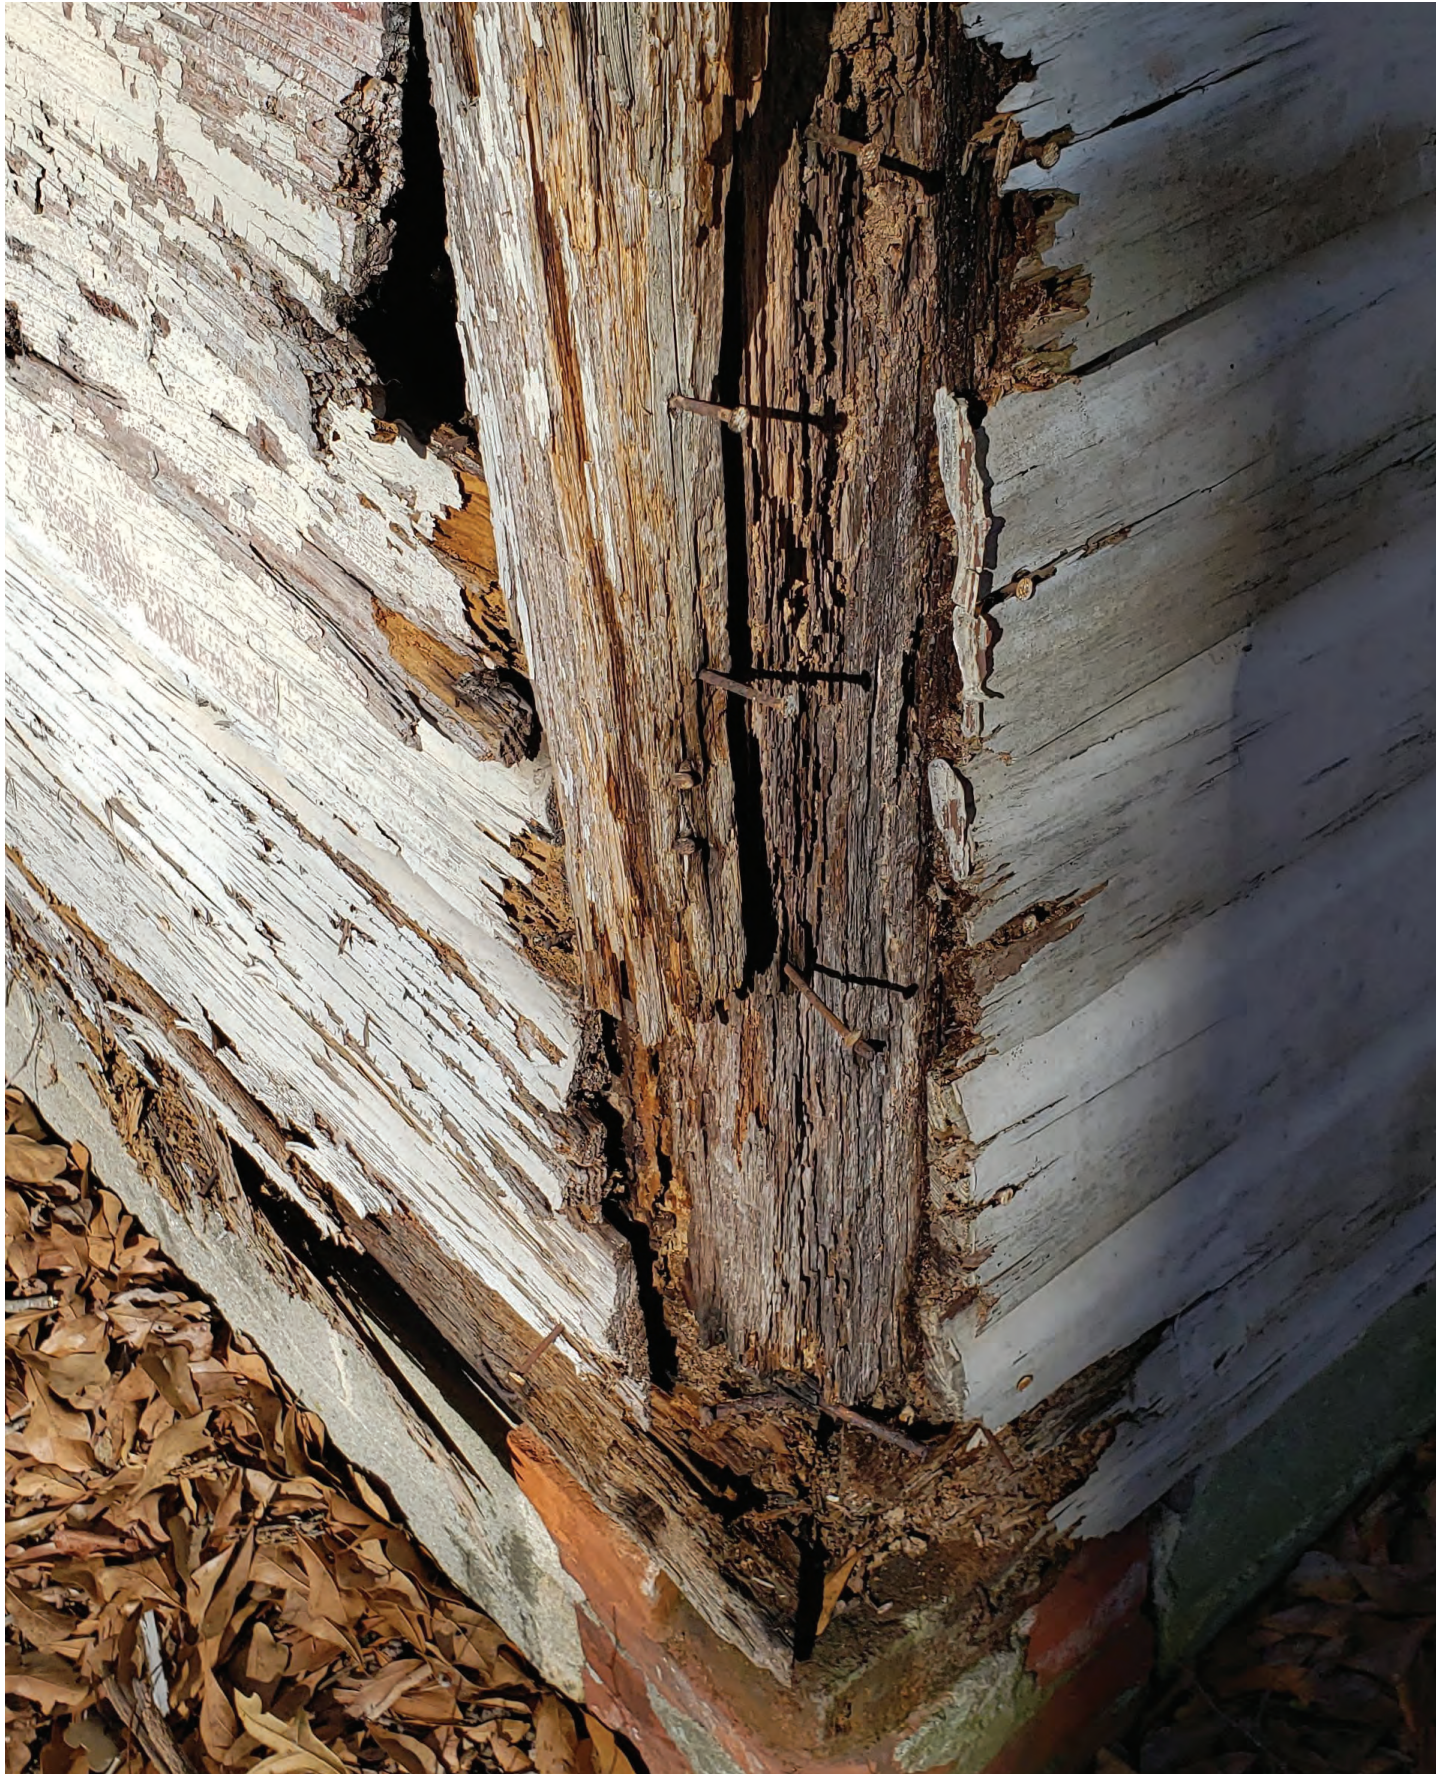
Brick pier foundation with extruded brick and portland cement mortar infill

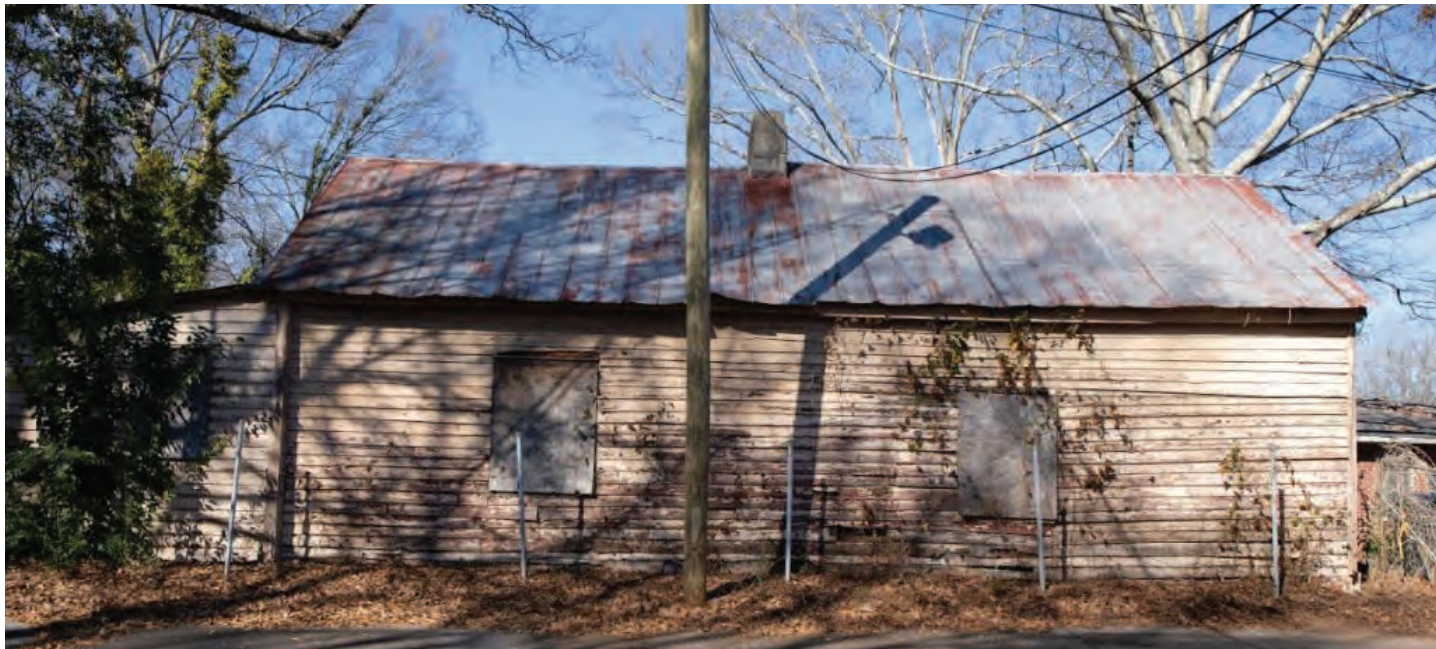
South facade showing different heights running along roofline

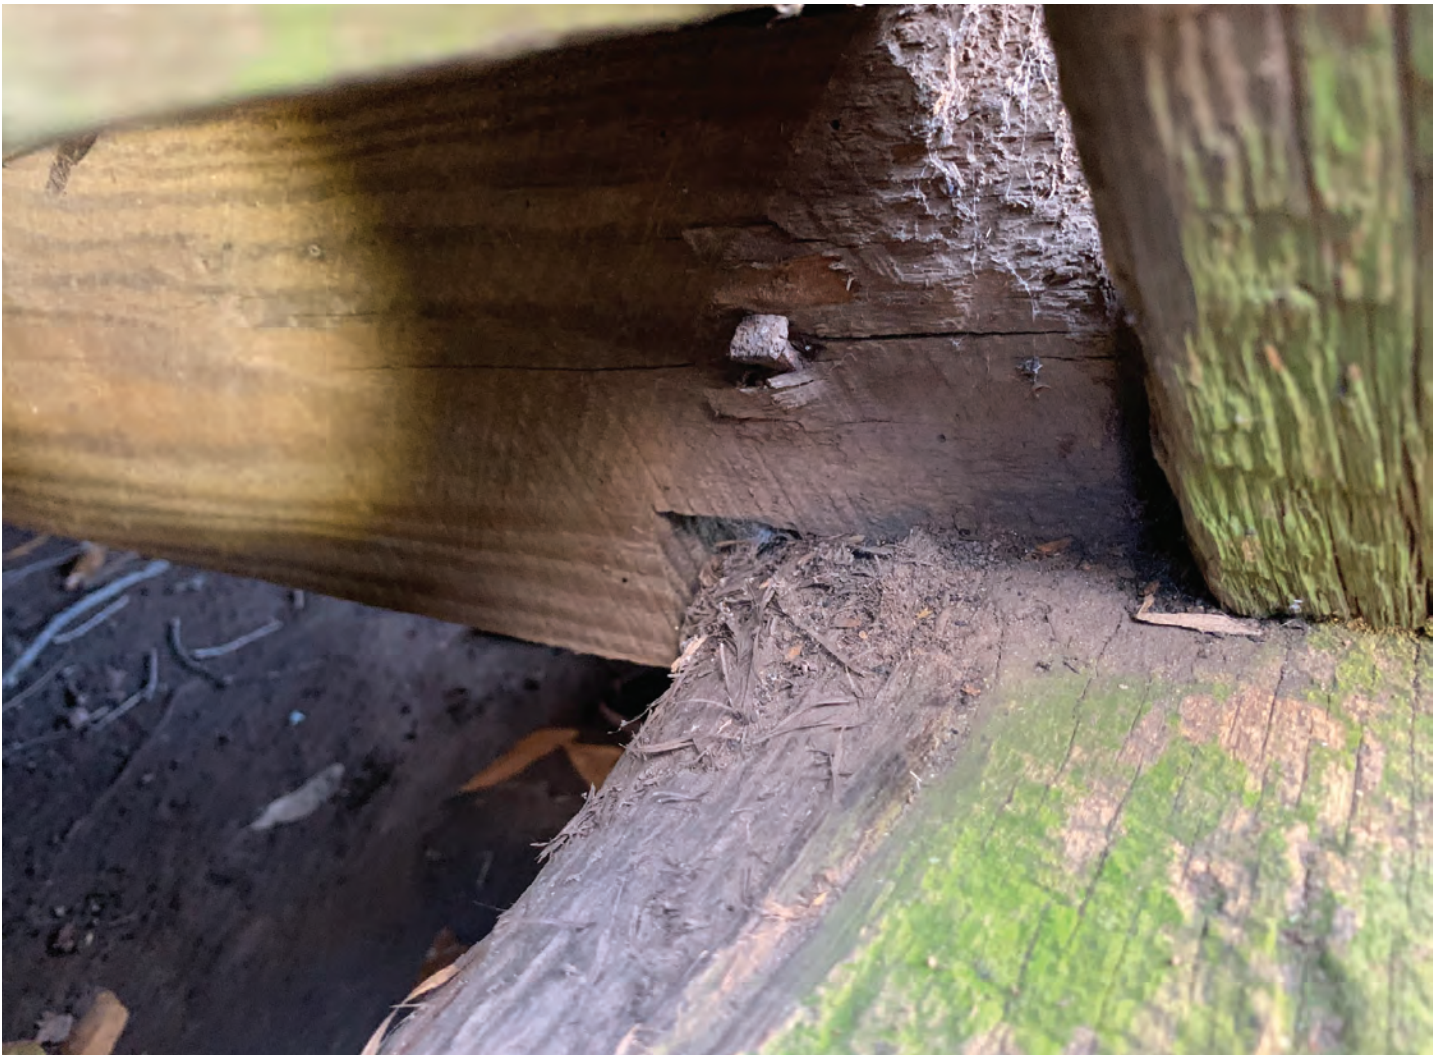
Floor joist at northeast corner showing circular saw marks and the reuse of materials such as a hand-wrought nail
